DDASaccident007

Humanitarian Demining Accident and Incident Database
AID

DDAS Accident Report

Report date: 22/01/2004	Accident number: 7
Accident time: not recorded	Accident Date: 10/03/1998
Where it occurred: Naghrak Village, Surkhroud District, Nangahar Province	Country: Afghanistan
Primary cause: Field control inadequacy (?)	Secondary cause: Management/control inadequacy (?)
Class: Excavation accident	Date of main report: [No date recorded]
ID original source: none	Name of source: MAPA/UNOCHA
Organisation: [Name removed]	
Mine/device: PMN AP blast	Ground condition: soft, wet
Date record created: 11/01/2004	Date last modified: 11/01/2004
No of victims: 1	No of documents: 2

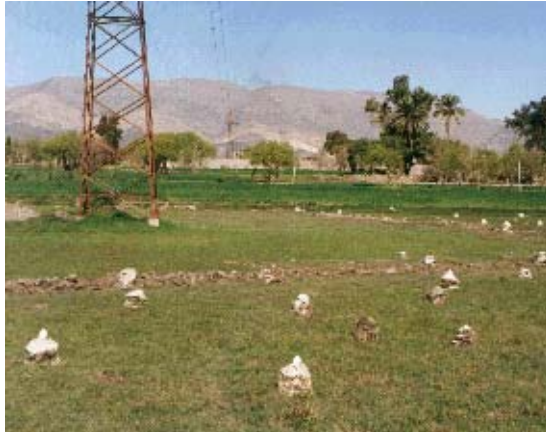
The photograph above shows the ground as grassy and soft/wet with no bamboo or bush. [The researcher photographed the pylon in March shortly after the event and before clearance had been completed]. The type of mine was identified from fragments found at the site.

The investigators determined that the victim used a "long handled shovel" while investigating a detector reading. He was digging by placing his foot on the shovel when the mine went off. The proximity to the power lines made the detectors signal continually in some places. The density of sub-surface roots made the demining group feel it was unsuitable for manual prodding.

Having visited the site and spoken with individuals involved, I find the suggestion that the site was overgrown and could not be prodded to be unfounded. The investigators called the site "damp" and it was "marshy" when I visited it. A back-hoe may well have been too heavy to deploy and proven entirely unsuitable.

The investigators recommended that Site Officers/Operations Officers should "thoroughly study and understand the task conditions" to ensure that they allocate the right resources to the task [this was thought to have been a "back-hoe" job].
