DDASaccident013

Humanitarian Demining Accident and Incident Database
AID

DDAS Accident Report

Report date: 22/01/2004	Accident number: 13
Accident time: 10:57	Accident Date: 08/03/1995
Where it occurred: MF No.1 Ta Ong West, Bentey Meanchey	Country: Cambodia
Primary cause: Field control inadequacy (?)	Secondary cause: Victim inattention (?)
Class: Victim inattention	Date of main report: 18/04/1995
ID original source: KN	Name of source: CMAC
Organisation: [Name removed]	
Mine/device: PMN-2 AP blast	Ground condition: not recorded
Date record created: 12/01/2004	Date last modified: 12/01/2004
No of victims: 1	No of documents: 1

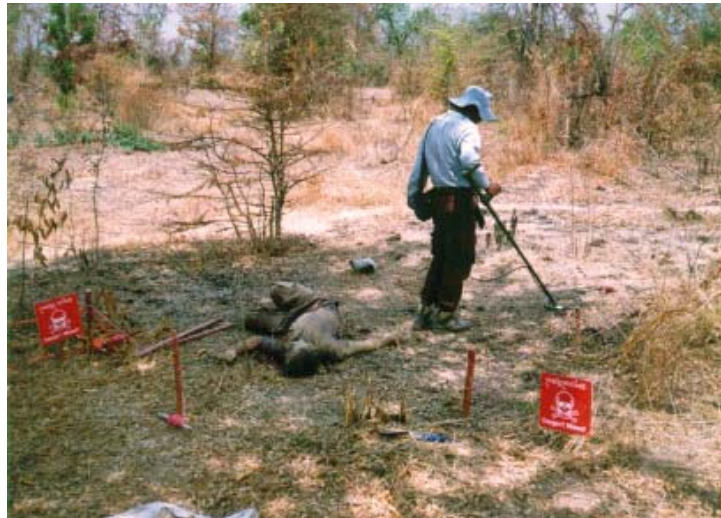
The victim was a detector man for his platoon and was working in his lane when at 10:57 the site manager blew a whistle to signal the beginning of a break period. The victim stood up and turned to return to the rest area but suddenly fell. He landed with most of his body in an

uncleared area and detonated a PMN-2 with "his head". He was blown back into the cleared lane and died instantly.

The picture above shows the area around the Victim being checked with a detector.

The investigators concluded that the victim had fainted because of dehydration and lack of sleep. The accident was therefore not due to a breach of SOPs but due to the victim's poor health.

The investigators recommended that the Site Manager, Platoon Commander and Section Commander were to make sure deminers had enough sleep (7-8 hours) and had taken enough water and food to the site. They said that deminers should be checked for their health each morning and not be allowed to work if there is any sign of illness. They also recommended that break times should be from 10:30 to 11:00, and 12:00 to 13:00.
