### DDASaccident018

HD-AID

*Humanitarian Demining Accident and Incident Database*

# DDAS Accident Report

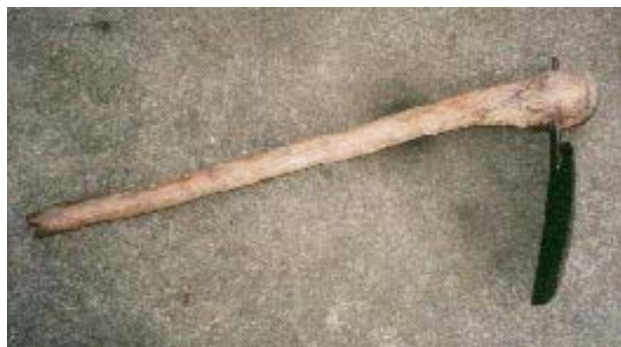
The "enxada head" found blast damaged [see Related papers] refers to a short handled African hoe or pick – so the tool used was not a conventional "trowel" but the hoe used by this group (and others) for excavation.

The photograph below shows an African hoe - called an "enxada" in Portuguese speaking areas. The handle is 60-90cms long (2-3 feet) long.

The use of the "enxada" (hoe) may seem inappropriate but in difficult ground conditions a similar tool is often found necessary. The length of the tool probably prevented serious hand injury - although its breaking into parts during the blast may have led to other injury.
