DDASaccident019

DDAS Accident Report

Report date: 22/01/2004	Accident number: 19
Accident time: 12:15	Accident Date: 27/03/1998
Where it occurred: Infulene-Komatipoort power line, Moamba District, Maputo Province	Country: Mozambique
Primary cause: Management/control inadequacy (?)	Secondary cause: Inadequate training (?)
Class: Survey accident	Date of main report: 21/04/1998
ID original source: No.76/CND/DED/98	Name of source: CND/IND
Organisation: [Name removed]	
Mine/device: PMN AP blast	Ground condition: rocky, dry
Date record created: 12/01/2004	Date last modified: 12/01/2004
No of victims: 2	No of documents: 3

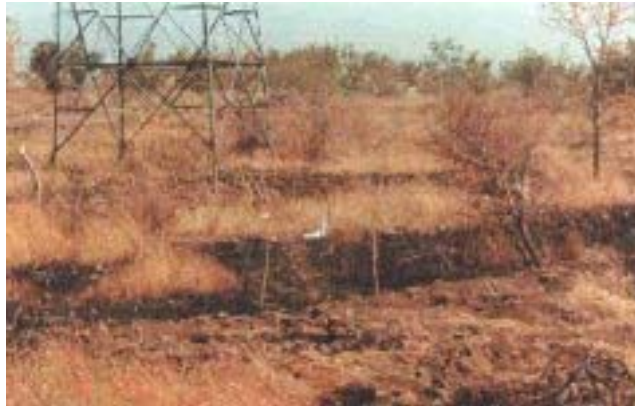
The weather at the time of the accident was cloudy and the ground was dry and stony with burnt vegetation and grass – as shown in the photograph below.

The accident occurred near a high voltage pylon to the south of Moamba town and approximately 22 km from the demining group's camp. The pylon was mined during the armed conflict and a barbed wire fence was put up to prevent the entry of people and animals. Outside this fence were other mines of the PMN, PMN-2 and PMD-6 types.

The Project Manager was opening an access lane to high voltage pylon number 58 and was in front of the other team members. About 8m behind him were the two Chief Instructors, with 2 to 4m between them. As they neared the area marked with barbed wire there was a sudden explosion. As a result both Chief Instructors were injured. Victim No.1 lost his left leg and had serious injuries to his left arm. Victim No.2 suffered minor injuries to his face, left ear and head as a result of fragments. The accident occurred 7-9 m from the pylon and about 1 km from the N2 road

1. The mine that caused the accident was identified as a PMN (Soviet made) and was accidentally activated by Victim No.1 when he stepped on it.
2. During the investigation it was shown that gross errors were made with regards to the methods used in the information gathering exercise. The following points were noted:
proper safety measures were not in place and were not observed.

1. In each and every case of an accident, IND must be the first to be informed through the formal channels.
2. After the first contact with IND it is necessary to produce a written report as soon as possible using the format approved and supplied by IND. Any attempt to hide or change information or to obstruct the investigation process will be considered to be an absolute lack of competence.
3. Every demining activity has to be based on the internal SOPs of each demining organisation/company and on the National Humanitarian Demining standards of IND.
4. It is absolutely necessary to invest in human resources guaranteeing the physical safety of people by every means possible.
