DDASaccident021

Humanitarian Demining Accident and Incident Database
AID

DDAS Accident Report

Report date: 22/01/2004	Accident number: 21
Accident time: 14:05	Accident Date: 24/03/1998
Where it occurred: Sabie, Moamba, Maputo Province	Country: Mozambique
Primary cause: Unavoidable (?)	Secondary cause: Management/control inadequacy (?)
Class: Excavation accident	Date of main report: 24/03/1998
ID original source: CR/JB	Name of source: CND/IND/MCM
Organisation: [Name removed]	
Mine/device: PMN-2 AP blast	Ground condition: hard, rocky
Date record created: 12/01/2004	Date last modified: 12/01/2004
No of victims: 1	No of documents: 3

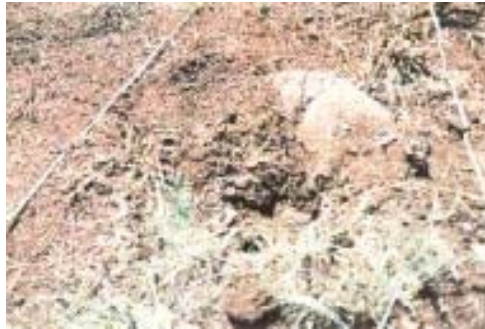
"The mine was located next to a rock in the ground which could be the reason why it was not detonated by the mechanical operation."

The picture below shows the crater next to the large rock.

The Team Leader told a driver to inform the base camp. While the victim was being stabilized I determined that he had detonated a PMN-2.... approximately 2.5m from the edge of the minefield" and inside his 1m wide lane. "Because of the nature of his wounds and the fact that his Ebex mine detector's search head was intact, I believe that [the victim] somehow detonated the mine while investigating a signal from his detector. This particular mine had also been indicated by the dog team earlier in the day. The mine was directly adjacent to a medium sized rock which probably explains why it was not detonated by the mechanical team earlier. The hard, compacted rocky soil in the area also added to the hazard."

The Platoon commander recommended that the working hours should be changed/reduced.
