# DDASaccident041

# DDAS Accident Report

<b>Report date:</b> 11/03/2004	<b>Accident number:</b> 41
<b>Accident time:</b> 12:45	<b>Accident Date:</b> 19/01/1995
<b>Where it occurred:</b> Mulangeni-Antonia District, Tete Province	<b>Country:</b> Mozambique
<b>Primary cause:</b> Field control inadequacy (?)	<b>Secondary cause:</b> Inadequate training (?)
<b>Class:</b> Excavation accident	<b>Date of main report:</b> 01/11/1995
<b>ID original source:</b> HB	<b>Name of source:</b> HB/NPA field
<b>Organisation:</b> [Name removed]	
<b>Mine/device:</b> PMN AP blast	<b>Ground condition:</b> not recorded
<b>Date record created:</b> 22/01/2004	<b>Date last modified:</b> 22/01/2004
<b>No of victims:</b> 1	<b>No of documents:</b> 2

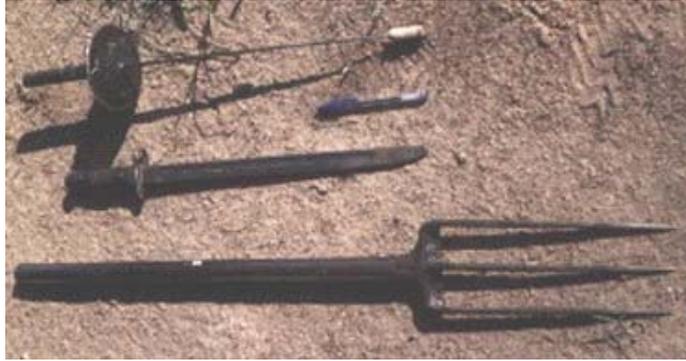
The demining group's three-pronged fork is a long-handled tool, shown in the picture below with an 18" (45cm) bayonet alongside it.

The use of a tool that kept his hand away from the detonation may have prevented serious hand injury, but may have caused the arm injury. The tool had three tines, meaning that it takes three times the force needed for a single tined tool to push it into the ground. Tactile feedback on ground obstructions would be less than from a single blade, so the use of the tool in an unapproved manner may have helped cause the accident. If so that may have been the consequence of *“Inadequate training”*.

An ex-pat Technical Advisor with the demining group at the time of the accident was interviewed in February 1998 (then working for another demining group). He said that the accident was caused by the use of the three pronged prodder with which the deminer could not "feel" the mine properly. This opinion has subsequently been opposed by other Technical Advisors to the group.
