DDASaccident085

Humanitarian Demining Accident and Incident Database
AID

DDAS Accident Report

| Where it occurred: Karti Ghous Uddin, Ward 7, Kabul Province | Country: Afghanistan |

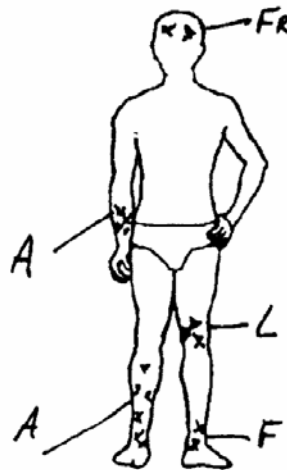
The medic's sketch of the injuries is reproduced above.

The victim's injuries were summarised as: minor injuries to right hand, left leg below knee, right shoulder, small fragments to eyes.
