# DDASaccident094

Humanitarian Demining Accident and Incident Database  
*AID*

# DDAS Accident Report

<b>Report date:</b> 19/04/2006	<b>Accident number:</b> 94
<b>Accident time:</b> not recorded	<b>Accident Date:</b> 01/06/1997
<b>Where it occurred:</b> Qala Muslim Village, Ward 7, Kabul city	<b>Country:</b> Afghanistan
<b>Primary cause:</b> Field control inadequacy (?)	<b>Secondary cause:</b> Inadequate equipment (?)
<b>Class:</b> Excavation accident	<b>Date of main report:</b> [No date recorded]
<b>ID original source:</b> none	<b>Name of source:</b> MAPA/UNOCHA
<b>Organisation:</b> [Name removed]	
<b>Mine/device:</b> PMN AP blast	<b>Ground condition:</b> hard rocks/stones
<b>Date record created:</b> 24/01/2004	<b>Date last modified:</b> 24/01/2004
<b>No of victims:</b> 1	<b>No of documents:</b> 1

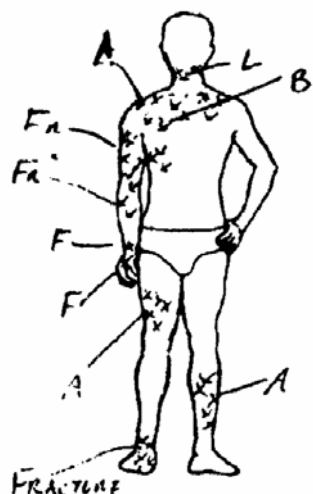
The victim's injuries were summarised as: fractured fingers on right hand, fragments on right arm, legs, chin, left hand and chest.

A medic's sketch (reproduced below) showed multiple fragments and abrasions to his chest and right arm, right thigh and left shin and a fractured ankle.
