DDASaccident095

Humanitarian Demining Accident and Incident Database
AID

DDAS Accident Report

Report date: 19/04/2006	Accident number: 95
Accident time: not recorded	Accident Date: 31/05/1997
Where it occurred: Ibrahim Khail Village, Gardiz City, Paktia Province	Country: Afghanistan
Primary cause: Field control inadequacy (?)	Secondary cause: Unavoidable (?)
Class: Excavation accident	Date of main report: [No date recorded]
ID original source: none	Name of source: MAPA/UNOCHA
Organisation: [Name removed]	
Mine/device: PMN AP blast	Ground condition: agricultural (abandoned) ditch/channel/trench hard
Date record created: 24/01/2004	Date last modified: 24/01/2004
No of victims: 1	No of documents: 1

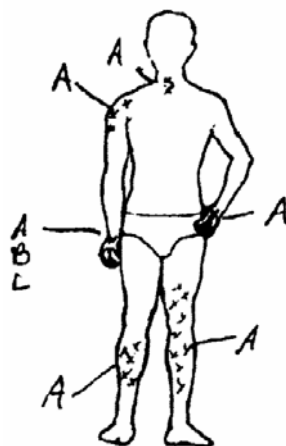
The victim's injuries were summarised as deep lacerations on his right hand, both legs, chin and right shoulder.

A medic's sketch (reproduced above) showed abrasions to his neck, right shoulder, lower right leg, lower and upper left leg and left hand, also abrasions, burns and lacerations to his left hand.
