DDASaccident109

DDAS Accident Report

Report date: 15/05/2006	Accident number: 109
Accident time: not recorded	Accident Date: 16/01/1997
Where it occurred: Hood Khail Village, Sorobi District, Kabul Province	Country: Afghanistan
Primary cause: Field control inadequacy (?)	Secondary cause: Inadequate equipment (?)
Class: Missed-mine accident	Date of main report: [No date recorded]
ID original source: none	Name of source: MAPA/UNOCHA
Organisation: Name removed	
Mine/device: PMN AP blast	Ground condition: hard residential/urban rocks/stones
Date record created: 12/02/2004	Date last modified: 12/02/2004
No of victims: 1	No of documents: 1

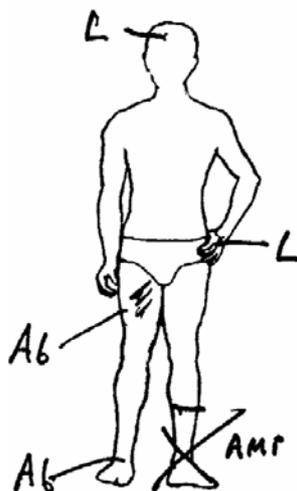
A medical report stated the victim suffered a below the knee amputation to his left leg, laceration of his scrotum, testes and index finger, abrasion of his right leg, thigh and a fragment in his right eye. A photograph showed the traumatic amputation of the left leg.

The medic's sketch (reproduced above) recorded no genital injury.
