DDASaccident119

Humanitarian Demining Accident and Incident Database
AID

DDAS Accident Report

Report date: 15/05/2006	Accident number: 119
Accident time: 11:10	Accident Date: 06/06/1998
Where it occurred: Tapa Tajbig, Ward 7, Kabul City	Country: Afghanistan
Primary cause: Field control inadequacy (?)	Secondary cause: Inadequate training (?)
Class: Demolition accident	Date of main report: [No date recorded]
ID original source: none	Name of source: MAPA/UNOCHA
Organisation: Name removed	
Mine/device: PMN AP blast	Ground condition: agricultural (abandoned) hard
Date record created: 12/02/2004	Date last modified: 12/02/2004
No of victims: 1	No of documents: 1

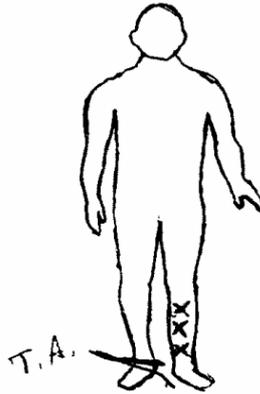
The medic controlled bleeding with a tourniquet and pressure bandage, and also irrigated and dressed the wounds. His sketch is reproduced below.

Photographs in the file showed the victim during first treatment. His right foot was missing just above the ankle. Lacerations to the left lower leg appeared minor and did not appear to affect the victim's foot. There were also lacerations on the palm of his left hand.
