DDASaccident119

Database of Demining Accidents
DDAS

DDAS Accident Report

Report date: 15/05/2006	Accident number: 119
Accident time: 11:10	Accident Date: 06/06/1998
Where it occurred: Tapa Tajbig, Ward 7, Kabul City	Country: Afghanistan
Primary cause: Field control inadequacy (?)	Secondary cause: Inadequate training (?)
Class: Demolition accident	Date of main report: [No date recorded]
ID original source: none	Name of source: MAPA/UNOCHA
Organisation: Name removed	
Mine/device: PMN AP blast	Ground condition: agricultural (abandoned) hard
Date record created: 12/02/2004	Date last modified: 12/02/2004
No of victims: 1	No of documents: 1

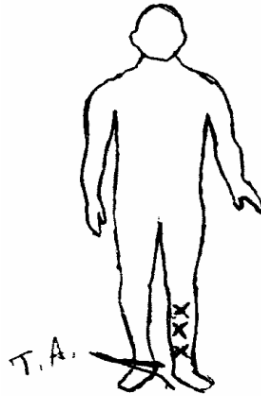
The medic controlled bleeding with a tourniquet and pressure bandage, and also irrigated and dressed the wounds. His sketch is reproduced below.

Photographs in the file showed the victim during first treatment. His right foot was missing just above the ankle. Lacerations to the left lower leg appeared minor and did not appear to affect the victim's foot. There were also lacerations on the palm of his left hand.
