DDASaccident120

Humanitarian Demining Accident and Incident Database
AID

DDAS Accident Report

Report date: 12/02/2004	Accident number: 120
Accident time: not recorded	Accident Date: 21/05/1999
Where it occurred: Plowshare minefield, Cordon Sanitaire, Mukumbura,	Country: Zimbabwe
Primary cause: Field control inadequacy (?)	Secondary cause: Inadequate training (?)
Class: Handling accident	Date of main report: [No date recorded]
ID original source: none	Name of source: KMS
Organisation: Name removed	
Mine/device: R2M2 AP blast	Ground condition: not recorded
Date record created: 12/02/2004	Date last modified: 12/02/2004
No of victims: 1	No of documents: 1

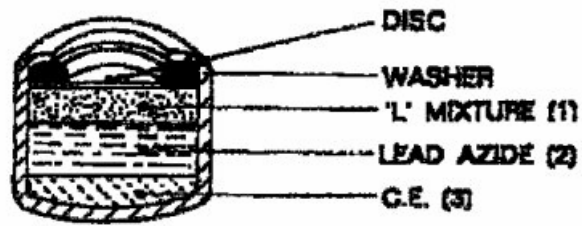
DETONATOR - 6.5 gr LZY

The accident site was examined by the Team Leader who found a charred rock and some plastic fragments and a stone in the ground that "also had charring". The fragments were identified as parts of the "surrounds of the percussion cap" of an R2M2 mine.

The investigator thought that the victim's story of prodding the unknown object with wire was "improbable". He stated that "the most likely cause is that he was holding the object between the thumb and forefinger of the left hand and struck the object with the right hand using the other stone found at the site which he held in an over hand grasp". [This may imply a lack of understanding on the part of the investigator because the detonator is not an "impact" type but a "stab-sensitive" type.]

The picture above shows a cut-away drawing of the stab-sensitive detonator,. It is easily initiated by prodding it with any hard object, such as a piece of stick or wire.
