DDASaccident121

Humanitarian Demining Accident and Incident Database

DDAS Accident Report

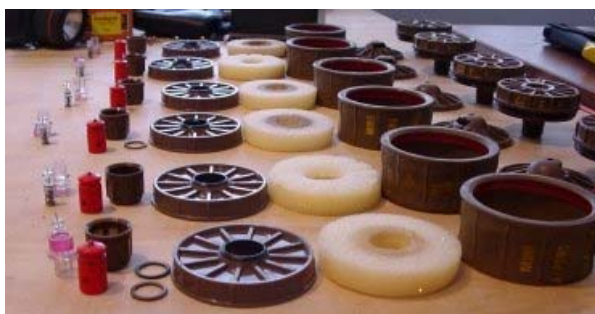
The "crystallisation" explanation given by the demining group does not make immediate sense. The researcher has dismantled many R2M2 mines in order to make detector test-pieces (some shown above).

In several cases the ball bearing mechanism has jammed and although the balls are lined up with their exit holes, they have not moved sideways to allow the spring-loaded pin to drop. In these cases, they could move at any time – which may explain why the mine went off as the supervisor unscrewed the booster charge. The picture alongside shows the mechanism with the pin just visible above the detonator.
