DDASaccident145

Humanitarian Demining Accident and Incident Database
AID

DDAS Accident Report

Report date: 16/05/2006	Accident number: 145
Accident time: not recorded	Accident Date: 07/10/1997
Where it occurred: Tapi Tajbek, Ward No. 6, Kabul City	Country: Afghanistan
Primary cause: Management/control inadequacy (?)	Secondary cause: Inadequate equipment (?)
Class: Excavation accident	Date of main report: [No date recorded]
ID original source: none	Name of source: MAPA/UNOCHA
Organisation: Name removed	
Mine/device: PMN AP blast	Ground condition: agricultural (abandoned) bushes/scrub hard
Date record created: 13/02/2004	Date last modified: 13/02/2004
No of victims: 1	No of documents: 2

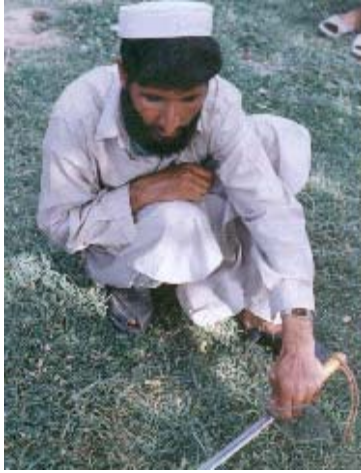
The deminer was interviewed in Kabul on 22nd July 1998 and photographed showing his working position when the accident occurred [he was using a short bayonet].

The victim was working as a deminer again at the time of the interview. He showed his scars – multiple on left leg, left hand and right arm.

He was not wearing a fragmentation vest at the time of the accident because one was not available. He was wearing a visor [not fully down]. The visor was examined and it was marked to 1mm depth, but not punctured.
