DDASaccident148

DDAS Accident Report

Report date: 16/05/2006	Accident number: 148
Accident time: not recorded	Accident Date: 15/09/1997
Where it occurred: Laghawat Village, Deyak District, Ghazni Province	Country: Afghanistan
Primary cause: Field control inadequacy (?)	Secondary cause: Unavoidable (?)
Class: Tripwire accident	Date of main report: [No date recorded]
ID original source: none	Name of source: MAPA/UNOCHA
Organisation: Name removed	
Mine/device: POMZ AP frag	Ground condition: agricultural (abandoned) hard
Date record created: 13/02/2004	Date last modified: 13/02/2004
No of victims: 2	No of documents: 2

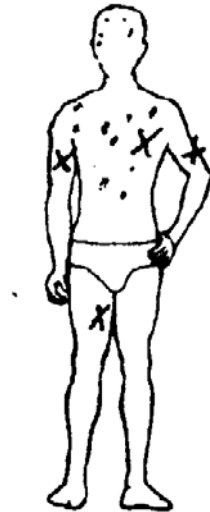
Victim No.2's injuries were summarised as: fragments to left arm, right thigh, right arm, face and chest.

A medic's sketch is reproduced below.
