DDASaccident149

Humanitarian Demining Accident and Incident Database
AID

DDAS Accident Report

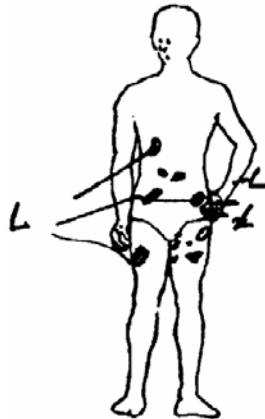
The victim's injuries were summarised as severe fragment lacerations to both his hands, his chest and his lower abdomen.

A medic's sketch (reproduced below) showed injuries concentrated on the lower torso and thighs, with small fragment damage on the right hand.
