### DDASaccident149

# DDAS Accident Report

<b>Report date:</b> 16/05/2006	<b>Accident number:</b> 149
<b>Accident time:</b> not recorded	<b>Accident Date:</b> 11/09/1997
<b>Where it occurred:</b> Pajak Village, Dehyak district, Ghazni Province	<b>Country:</b> Afghanistan
<b>Primary cause:</b> Field control inadequacy (?)	<b>Secondary cause:</b> Inadequate equipment (?)
<b>Class:</b> Detection accident	<b>Date of main report:</b> [No date recorded]
<b>ID original source:</b> none	<b>Name of source:</b> MAPA/UNOCHA
<b>Organisation:</b> Name removed	
<b>Mine/device:</b> POMZ AP frag	<b>Ground condition:</b> agricultural (abandoned) bushes/scrub hard
<b>Date record created:</b> 13/02/2004	<b>Date last modified:</b> 13/02/2004
<b>No of victims:</b> 1	<b>No of documents:</b> 1

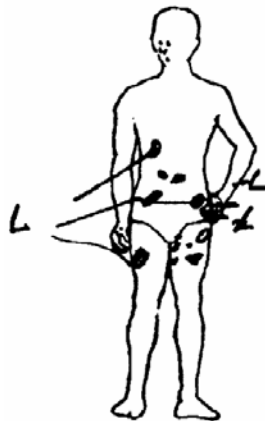
The victim's injuries were summarised as severe fragment lacerations to both his hands, his chest and his lower abdomen.

A medic's sketch (reproduced below) showed injuries concentrated on the lower torso and thighs, with small fragment damage on the right hand.

The demining group reported that the victim had sustained serious injuries to both thighs when he detonated a POMZ while using a detector.

A claim was forwarded to the insurers by the UN MAC on 23<sup>rd</sup> April 1998 saying that the victim suffered multiple penetrating injuries of abdomen anterior wall and posterior wall (both buttocks) – gluteal and sacral regions. "Some fragments (pellets) remain". The insurers were informed that the victim was ready to return to work on 23<sup>rd</sup> April 1998.
