## DDASaccident150

# DDAS Accident Report

<b>Report date:</b> 16/05/2006	<b>Accident number:</b> 150
<b>Accident time:</b> not recorded	<b>Accident Date:</b> 07/09/1997
<b>Where it occurred:</b> Qalai Muslim, Ward 7, Kabul city	<b>Country:</b> Afghanistan
<b>Primary cause:</b> Field control inadequacy (?)	<b>Secondary cause:</b> Field control inadequacy (?)
<b>Class:</b> Excavation accident	<b>Date of main report:</b> [No date recorded]
<b>ID original source:</b> none	<b>Name of source:</b> MAPA/UNOCHA
<b>Organisation:</b> Name removed	
<b>Mine/device:</b> PMN AP blast	<b>Ground condition:</b> building rubble hard metal scrap residential/urban
<b>Date record created:</b> 13/02/2004	<b>Date last modified:</b> 13/02/2004
<b>No of victims:</b> 1	<b>No of documents:</b> 1

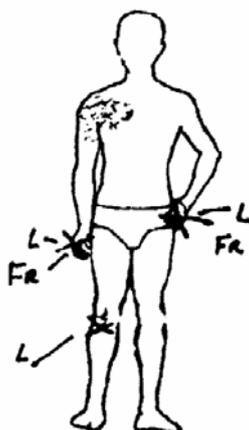
The victim's injuries were summarised as open fractures in the fingers of both hands, penetrative wounds in his right knee and superficial wounds to his right arm and chest.

A medic's sketch (reproduced below) showed fractures and lacerations to his fingers and chest and a shoulder and knee injury.

The demining group reported that the victim had suffered compound fractures of his right thumb and index finger, left index finger, a penetrating wound to his left knee, and superficial wounds to his right arm and chest.
