DDASaccident155

Humanitarian Demining Accident and Incident Database
AID

DDAS Accident Report

Report date: 17/05/2006	Accident number: 155
Accident time: 08:05	Accident Date: 24/03/1999
Where it occurred: Kapfudze village, Mukumbura	Country: Zimbabwe
Primary cause: Field control inadequacy (?)	Secondary cause: Field control inadequacy (?)
Class: Excavation accident	Date of main report: [No date recorded]
ID original source: none	Name of source: KMS
Organisation: Name removed	
Mine/device: R2M2 AP blast	Ground condition: hard
Date record created: 13/02/2004	Date last modified: 13/02/2004
No of victims: 1	No of documents: 2

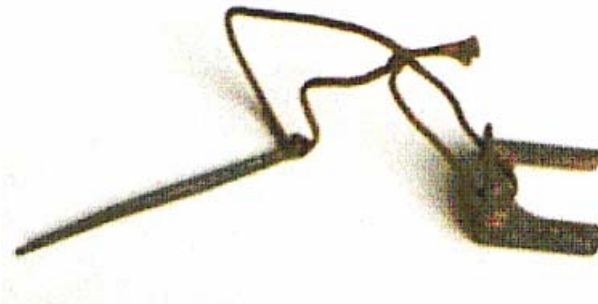
The Site supervisor recommended that the group find alternative methods for investigating signals where the ground was hard or mines deeply buried. He observed that the steel safety clip [galvanised, shown above] was being found away from the mine, so masking the exact location of the mine.

Deminers could start investigating a signal thinking they were 15cm behind a mine and then find that they were actually prodding directly onto it. He recommended that prodding should start 20-25cm behind a signal in future.
