DDASaccident159

Humanitarian Demining Accident and Incident Database
AID

DDAS Accident Report

| Where it occurred: Trapeing Phlong, Ponhea Krek, Kampong Chan Province | Country: Cambodia |

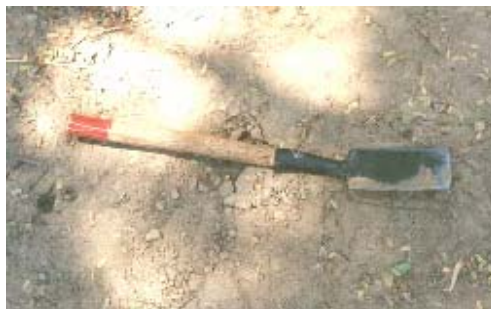
[The picture shows the type of "trowel" used by the victim.]

The failure of the tool demonstrates the importance that should be attached to ensuring that hand-tools do not separate in a blast. The tool was long, but not fixed together adequately and may not have been made of suitably pliable steel. The secondary cause is listed as "*Inadequate equipment*".
