DDASaccident161

Humanitarian Demining Accident and Incident Database
AID

DDAS Accident Report

Report date: 17/05/2006	Accident number: 161
Accident time: 08:30	Accident Date: 05/10/1998
Where it occurred: Trapeing Phlong Commune, Ponhea Krek, Kampong Chan Province	Country: Cambodia
Primary cause: Unavoidable (?)	Secondary cause: Inadequate equipment (?)
Class: Excavation accident	Date of main report: 12/10/1998
ID original source: none	Name of source: CMAC
Organisation: Name removed	
Mine/device: M14 AP blast	Ground condition: bushes/scrub dry/dusty electromagnetic hidden root mat
Date record created: 14/02/2004	Date last modified: 29/02/2004
No of victims: 1	No of documents: 2

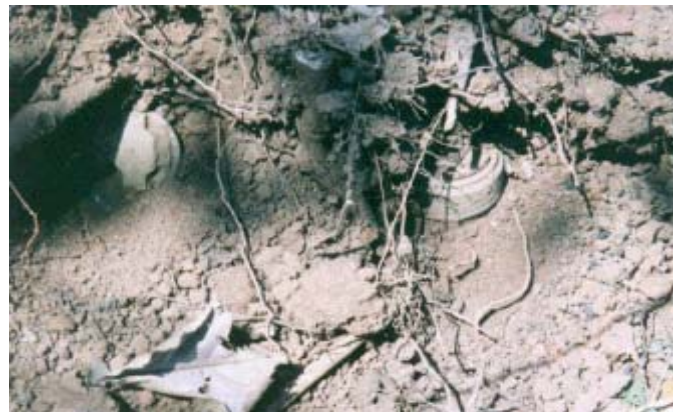
The picture below shows two M14 mines as they were found - one of them at an angle. The picture was taken in the same area as this accident occurred.

Basically this appears to have been an accident where the deminer initiated the mine whilst prodding. His partner had located the item and marked it and both of them were sure that there was a mine present in this location. There was less evidence of roots etc present in the location, although there were some, it does not appear that they were a major contributory factor. It is pure speculation, but it may have been the case that the mine was in the same attitude as the picture I gave you a copy of (from the same site).

The country MAC investigation recommended that the policy of leaving mines exposed while looking for other members of the same group be reconsidered. In one of the demining organisation's reports (translated from Khmer) it was suggested that deminers should operate lying on a plastic sheet.
