DDASaccident162

Humanitarian Demining Accident and Incident Database

DDAS Accident Report

Report date: 17/05/2006	Accident number: 162
Accident time: 12:30	Accident Date: 29/09/1998
Where it occurred: Boskhnor, Banan District, Battambang Province	Country: Cambodia
Primary cause: Field control inadequacy (?)	Secondary cause: Field control inadequacy (?)
Class: Excavation accident	Date of main report: 14/10/1998
ID original source: TA/PS/PT	Name of source: CMAC
Organisation: Name removed	
Mine/device: Type 72 AP blast	Ground condition: electromagnetic wet
Date record created: 14/02/2004	Date last modified: 14/02/2004
No of victims: 1	No of documents: 2

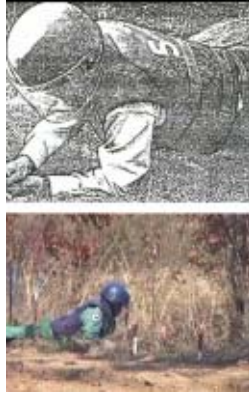
The victim was working in an "unauthorised semi-prone" position. (He claimed to have been lying on a "blue sheet" provided to keep deminers from getting too wet or muddy but there was some doubt over this). A photograph illustrated the victim's supposed position – showing a deminer lying on his side with his torso raised as he leaned on one elbow.

"The unorthodox prodding position used by [the victim] was a direct result of the poor working conditions he was placed in. Although it is not a direct contribution to the accident, it is clear that by using a semi-prone position it must have been difficult to properly investigate detector readings." [Note that the victim was not investigating detector readings if his detector signalled everywhere.]

The picture above (top) was included by the investigators to explain the victim's position. The picture beneath it was taken by the researcher in 1999 - a position observed being used by the group whenever press and observers are present. [Having tried it, it is not possible to lie flatter than this and still have a good view of what you are excavating.]

The internal investigators recommended that the Supervisor should be permanently relieved of his position [he was] and that the minefield manager should be given a written warning. Also that a small garden tool should be issued to aid excavation, and that all deminers should be made aware of their right to refuse to work in conditions that conflicted with SOPs.
