DDASaccident165

DDAS Accident Report

Report date: 17/05/2006	Accident number: 165
Accident time: 08:27	Accident Date: 23/12/1997
Where it occurred: Mok Heoun, Route 502, Banteay Meanchey Province	Country: Cambodia
Primary cause: Unavoidable (?)	Secondary cause: Unavoidable (?)
Class: Excavation accident	Date of main report: [No date recorded]
ID original source: none	Name of source: CMAC
Organisation: Name removed	
Mine/device: AP blast (unrecorded)	Ground condition: electromagnetic hard
Date record created: 14/02/2004	Date last modified: 14/02/2004
No of victims: 1	No of documents: 1

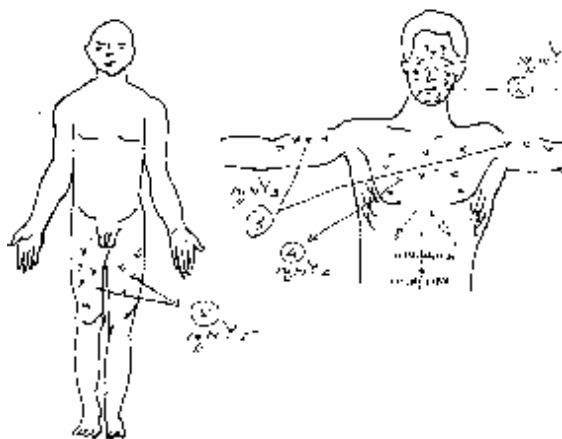
The victim's eyes were both swollen and full of dust and sand, and he had minor injuries to his chest, upper arms and thighs. The accident occurred at 08:27 and he arrived at Mongkul Borey Hospital at 10:00.

A doctor's note in the file stated that the victim's right eye became infected by dust from the explosion and it was removed on 27th December 1997 to prevent infection spreading to the other eye.

This medical sketch accompanied a compensation claim.
