DDASaccident166

Humanitarian Demining Accident and Incident Database

DDAS Accident Report

Report date: 17/05/2006	Accident number: 166
Accident time: 07:40	Accident Date: 28/11/1997
Where it occurred: Mok Heoun, Road 502, Banteay Meanchey Province	Country: Cambodia
Primary cause: Field control inadequacy (?)	Secondary cause: Inadequate equipment (?)
Class: Missed-mine accident	Date of main report: [No date recorded]
ID original source: none	Name of source: CMAC
Organisation: Name removed	
Mine/device: Type 72 AP blast	Ground condition: bushes/scrub electromagnetic grass/grazing area hard
Date record created: 14/02/2004	Date last modified: 14/02/2004
No of victims: 1	No of documents: 2

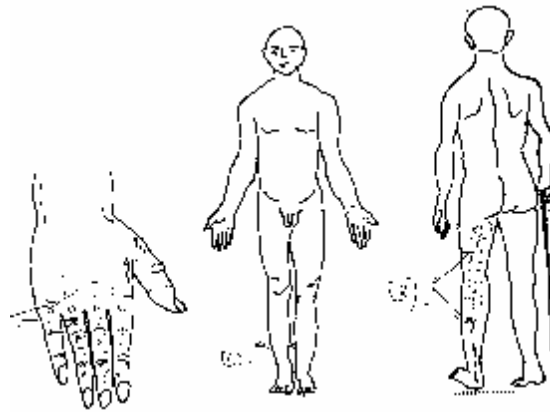
A brief medical report in Khmer was found. It stated that the victim arrived in hospital at 09:15 [conflicting with 09:30 in the Accident report] and that his right leg had been amputated below the knee. His right thigh was also injured and his left leg had suffered scattered fragmentation wounds.

This medical sketch accompanied a compensation claim.
