DDASaccident180

Humanitarian Demining Accident and Incident Database
AID

DDAS Accident Report

Report date: 18/05/2006	Accident number: 180
Accident time: 10:30	Accident Date: 02/02/1996
Where it occurred: Kaup Prich, Battambang Province	Country: Cambodia
Primary cause: Field control inadequacy (?)	Secondary cause: Inadequate equipment (?)
Class: Missed-mine accident	Date of main report: [No date recorded]
ID original source: none	Name of source: CMAC
Organisation: Name removed	
Mine/device: Type 72 AP blast	Ground condition: not recorded
Date record created: 14/02/2004	Date last modified: 14/02/2004
No of victims: 1	No of documents: 1

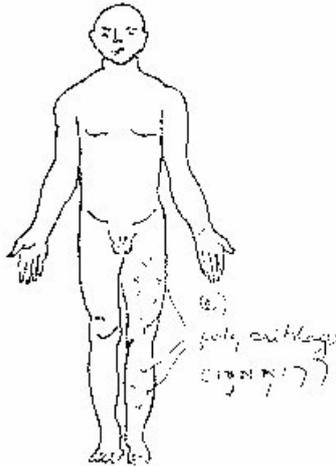
A medical report stated that the victim was unable to use one leg, his right heel was damaged and his left calf was lightly injured.

By 5th February amputation of the lower leg was being considered. This was not done. He was discharged from hospital on 27th March 1996 when the doctor stated that his right leg injury has left him with an 80% disability with wounds that would take 6-7 months to heal. The left leg injury had already completely recovered. The doctor recommended that the leg injury be treated as a leg loss for compensation purposes.

The sketch below is reproduced from the compensation file.
