Humanitarian Demining Accident and Incident Database
AID

DDAS Accident Report

Report date: 15/05/2006	Accident number: 206
Accident time: 11:30	Accident Date: 08/06/1999
Where it occurred: Grebnica, Domaljevac, Posavski (Canton 2)	Country: Bosnia Herzegovina
Primary cause: Management/control inadequacy (?)	Secondary cause: Inadequate training (?)
Class: Demolition accident	Date of main report: 17/06/1999
ID original source: PC/NH/RB/MM	Name of source: BiH MAC
Organisation: Name removed	
Mine/device: PROM-1 AP Bfrag	Ground condition: grass/grazing area metal scrap residential/urban
Date record created: 15/02/2004	Date last modified: 17/03/2004
No of victims: 1	No of documents: 2

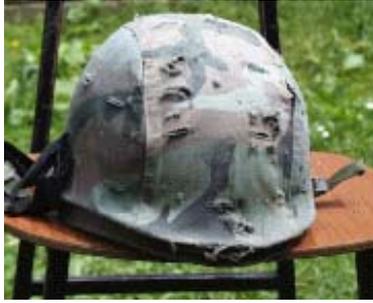
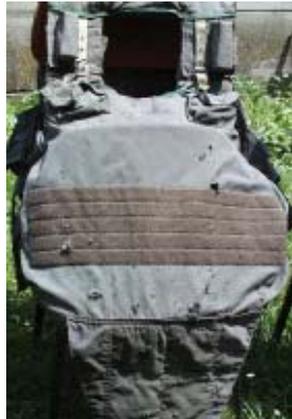
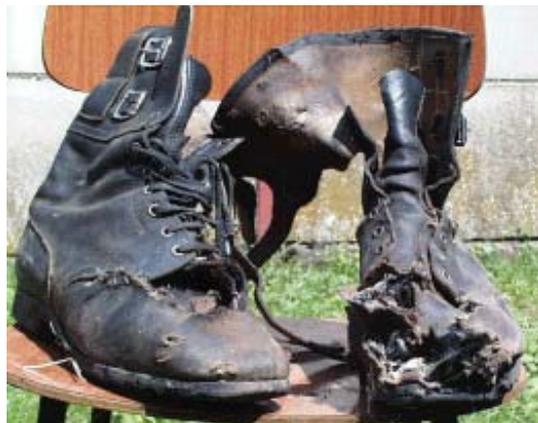
The investigators examined the protective equipment being used. The victim was wearing "an old US military helmet, flak-jacket and military boots". The equipment did not meet the MAC's standard. The helmet had a heavy steel outer and plastic liner. It had no visor. There were three holes on the outside of the helmet where fragments had penetrated. The chin strap was not fastened. 53 fragment holes were counted on the external skin of the frag-jacket. "Eleven fragmentation holes crossed to the level of the chest on the left side". There was no blood on the jacket. Several fragments remained inside it. There were safety "pins" for the PROM attached to the jacket shoulder. [The make of jacket was not identified.]

The victim's boots were torn in the toe area with possible frag holes on the upper. "No trace of blood" was found.

[The pictures show the victim's PPE. The helmet was "holed" and the toe of one boot shredded. The frag jacket took a lot of impacts low down.]

There were many failures of management at the site as identified by the investigators. However, their identification of the protection as inadequate was only well targeted as far as it applied to the failure to provide a visor. As the results of other close-quarter PROM-1 detonations show, a STANAG V50 of 450m/s is unable to provide protection against this threat. The victim would almost certainly still have died if he had been wearing the required protection.

Further recommendations were that work at the site must stop, authorisation for the demining company to operate must be rescinded and its request for authorisation rejected "forthwith". Also that no demining company should be able to continue a demining operation without a visit of MAC inspectors during the first five days. They also recommended that the country MAC should issue a "technical bulletin...on demolition procedures for the PROM-1" and that all protective clothing and equipment for demining must be in accordance with STANAG 2902.

22. The Protective Clothing and Equipment is to be in conformity to International Standards and the former military equipment cannot be agreed as safety for humanitarian demining operations.
