DDASaccident208

DDAS Accident Report

REPORT OF BOARD OF INQUIRY INTO ACCIDENT 08 APRIL 1999

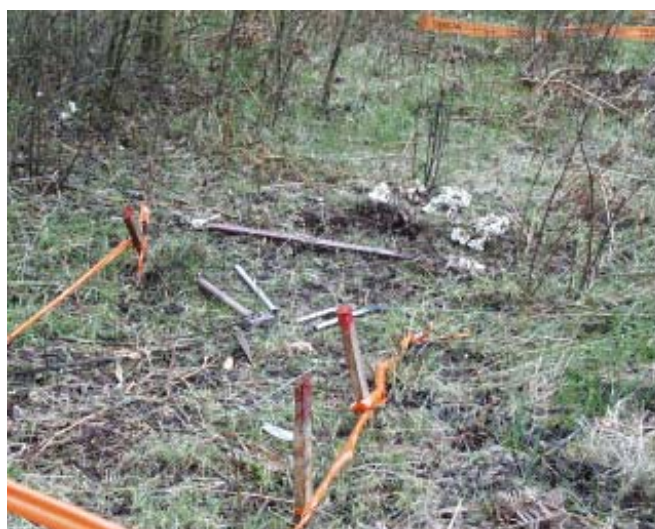
The accident occurred in an open corner of the site with a dirt road 100 metres to the North and a line of trees and bushes "directly adjacent". The weather was cloudy but dry and the temperature about 15°C. The victim was using a Schiebel AN 19/2 detector.

[The photograph shows the accident site.]

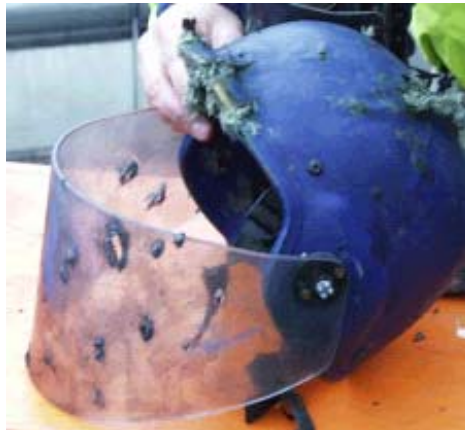
The victim "received extensive injuries in the head, left shoulder and left side of the chest". The mine crater was in front of his end-of-lane marker by a few centimetres. His helmet was torn from his head in the blast - "the chin belt was ripped" - and was found five metres away. The visor was penetrated in twelve places. The helmet was damaged. The frag-jacket "was completely torn" with "piercings in the shoulder and chest area".

[The photograph shows the victim's helmet. The picture below shows the victim's body armour.]

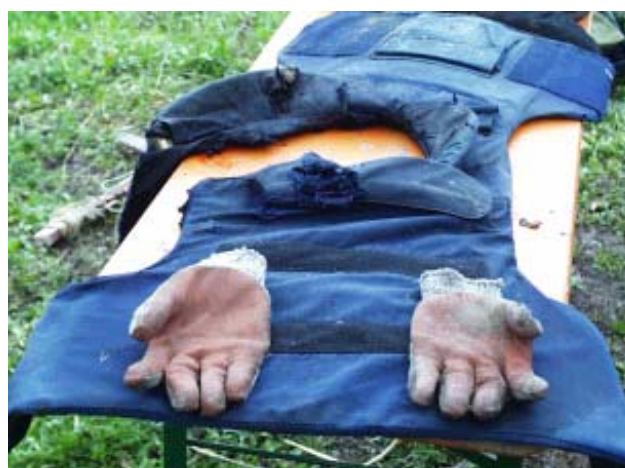
56. The de-miner involved wore a Kevlar helmet with visor, a Kevlar flak jacket, hand gloves and boots. The equipment was of good quality and had been in good order before the accident.
57. In the blast the helmet was torn off the victim's head, the chin belt was ripped, the visor was pierced on two spots and the helmet showed several impacts of which one had caused damage on the inside of the helmet. The helmet was found 5 metres away from the place of the accident.
58. The left shoulder of the flak jacket was completely torn, showing several piercings in the shoulder and chest area.
59. The gloves and boots were undamaged. It is unlikely that the victim wore the gloves at the time of the accident.
60. Photographs of Personal Protective Equipment are shown at Annex J.
