DDASaccident209

DDAS Accident Report

Report date: 15/05/2006	Accident number: 209
Accident time: 11:15	Accident Date: 15/03/1999
Where it occurred: Grad, Orasca, Una Santon Canton	Country: Bosnia Herzegovina
Primary cause: Management/control inadequacy (?)	Secondary cause: Inadequate training (?)
Class: Survey accident	Date of main report: 17/03/1999
ID original source: WL/RB/HG/JH	Name of source: BiH MAC
Organisation: Name removed	
Mine/device: AP blast (unrecorded)	Ground condition: dry/dusty grass/grazing area sparse trees
Date record created: 15/02/2004	Date last modified: 15/02/2004
No of victims: 1	No of documents: 2

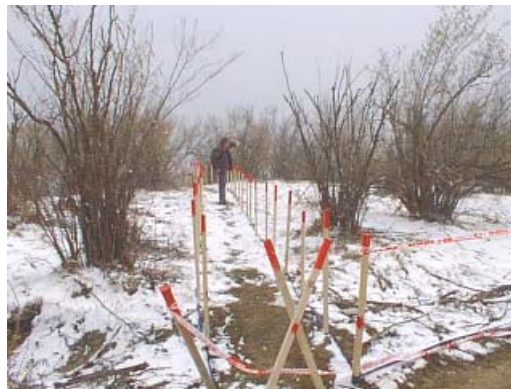
[The picture above was taken during the accident investigation.]

The area where the accident occurred "was described as rough hillside and pastureland" with a sparse covering of small trees and bushes. The grass had been close cropped by grazing animals "and by the activities of the local population". A photograph showed cropped grass and scrubby bush. The ground was dry. The detonation occurred about 15m from an unsurfaced track and about 2 km from the nearest tarred road. There were lines of defensive trenches near the area, the closest being 30m from the accident site. A previous demining operation had cleared 13,000 square metres in the area in 1997 on the opposite side of the track about 100m from the accident site. A mortar and two PMA-2s were found during this clearance.
