## DDASaccident210

# DDAS Accident Report

REPORT OF BOARD OF INQUIRY INTO ACCIDENT 19 OCT 1998

23 October 1998 [Annexes were not made available.]

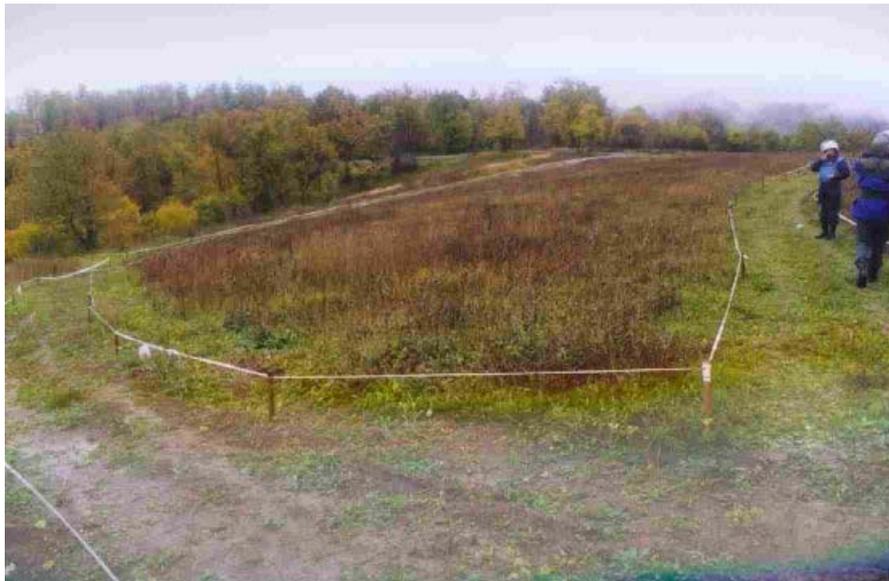
The photograph above shows the area of the accident.

The accident occurred on an overgrown and disused track between lines of trees. The ground was described as "rocky and broken". The area was being prepared for the use of dogs, so lanes were being cleared to make grids [providing safe lanes for the dogs in a manner that allowed more than one dog team to work simultaneously]. Three PROM-1 mines had been found in the area (two without fuses). Other mines found included PMA-3s and TMRP-6 & TMM-1 AT mines. The original minefield record indicated that the PROM-1 involved in this accident was the last remaining in the part of the site being cleared.
