DDASaccident211

DDAS Accident Report

Report date: 15/05/2006	Accident number: 211
Accident time: 06:40	Accident Date: 31/08/1998
Where it occurred: Nr Route Arizona, 25 Km from Brcko	Country: Bosnia Herzegovina
Primary cause: Field control inadequacy (?)	Secondary cause: Management/control inadequacy (?)
Class: Vegetation removal accident	Date of main report: 04/09/1998
ID original source: WL/WM/IP/NH/SB	Name of source: BiH MAC
Organisation: Name removed	
Mine/device: PROM-1 AP Bfrag	Ground condition: bushes/scrub grass/grazing area rocks/stones route (verge) trees
Date record created: 15/02/2004	Date last modified: 15/02/2004
No of victims: 2	No of documents: 2

REPORT OF BOARD OF INQUIRY INTO ACCIDENT 31 AUGUST 1998

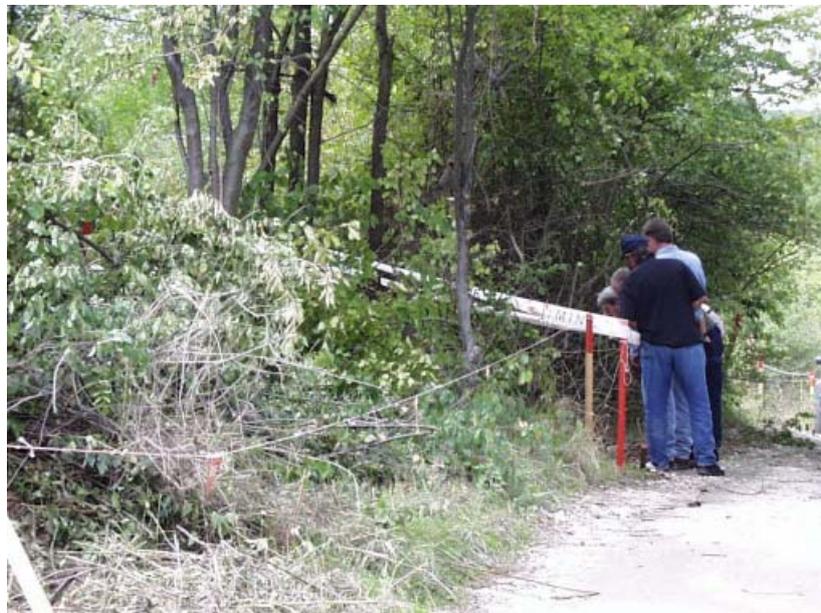
[The picture above shows the accident site.]

16. The task area where the accident occurred is a route verge, next to an unmade road. The verge is thickly vegetated with grass, weeds and small bushes and trees. The site is graded as Category C by the Federation PIU.

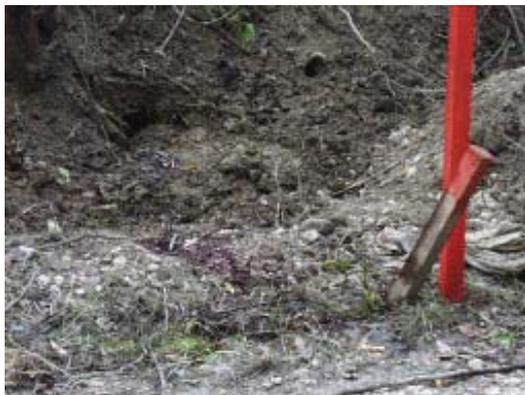
[The picture shows the mine crater.]

41. The mine involved was a PROM-1, bounding Anti Personnel fragmentation mine. This was confirmed by the discovery of the mine's base-plate in the bottom of the crater. Photographs of the crater are shown at Annex E.

42. The mine was in an area that had been previously worked in, approximately half a metre inside the cleared area. Vegetation, including small trees and bushes had been cut around where the mine was laid.
