DDASaccident218

Humanitarian Demining Accident and Incident Database
AID

DDAS Accident Report

Report date: 15/05/2006	Accident number: 218
Accident time: not recorded	Accident Date: 15/04/1998
Where it occurred: Near Ljubine	Country: Bosnia Herzegovina
Primary cause: Management/control inadequacy (?)	Secondary cause: Inadequate training (?)
Class: Victim inattention	Date of main report: [No date recorded]
ID original source: TA	Name of source: BiH MAC
Organisation: Name removed	
Mine/device: PMA-3 AP blast	Ground condition: rocks/stones
Date record created: 16/02/2004	Date last modified: 16/02/2004
No of victims: 1	No of documents: 1

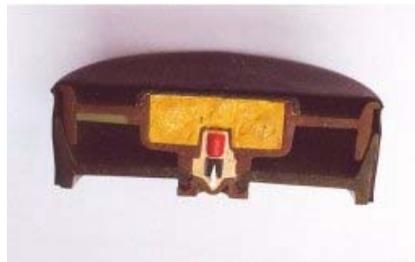
The deminer challenged him and he said "no problem" and walked on. After 25 metres he trod on a PMA-3 and was injured. He had stepped on a rock that had a mine beneath it. [He may have been using the rocks as stepping stones.] The team conducted a CASEVAC operation. They believed that the victim had probably sustained broken bones in his foot.

It is possible that the victim was stepping on stones as he moved forward and was fortunate that the mine that initiated beneath the stone was small and the stone protected him from blast wave damage. Alternatively, he may have been fortunate and stepped on the side of the PMA-3 and so avoided treading on the HE charge in the centre.

The injuries resulting from stepping on a PMA-3 vary from traumatic amputation to minor bruising. The picture below shows why this happens. It shows a cut-away section through a PMA-3. The 35g Tetryl is in the top and centre of the mine. The area of pressure-plate surrounding the HE is actually larger than the area of pressure-plate over it. If a victim is fortunate, they step on the pressure plate but the explosive charge is not beneath their foot.
