## DDASaccident223

# DDAS Accident Report

REPORT ON 9 OCTOBER 97 MINE ACCIDENT NEAR LIME FACTORY, DOBOJ

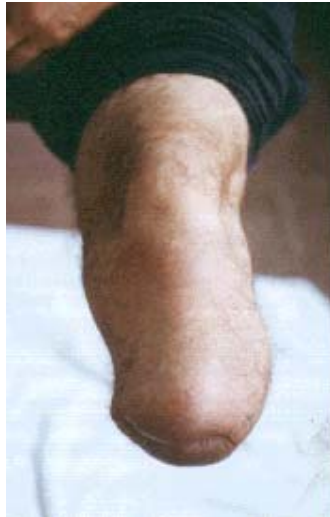
On 11<sup>th</sup> November he was moved to a military hospital and on 13<sup>th</sup> November they surgically amputated his leg removing "some small bone" probably three centimetres. Because much of his calf muscle was still intact, they could wrap his stump without grafting.

He allowed his stump to be photographed as shown above.
