DDASaccident227

Humanitarian Demining Accident and Incident Database

DDAS Accident Report

REPORT ON MINE ACCIDENT AT SEVARLIJE, NEAR DOBOJ

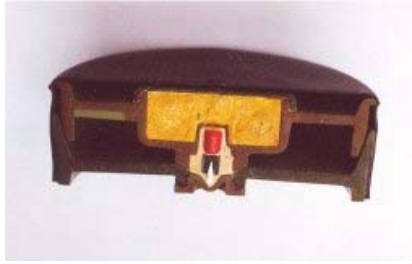
The injuries resulting from stepping on a PMA-3 vary from traumatic amputation to minor bruising. The picture below shows why this can happen. It shows a cut-away section through a PMA-3. The 35g Tetryl is in the top and centre of the mine. The area of pressure-plate surrounding the HE is actually larger than the area of pressure-plate over it. If a victim is fortunate, they step on the pressure plate but the explosive charge is not beneath their foot.

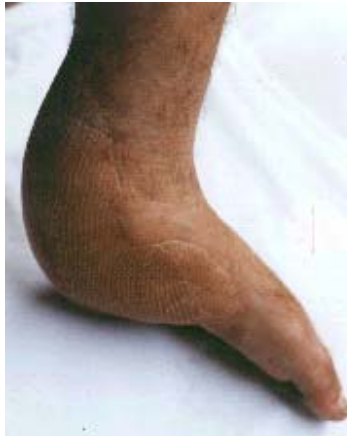
At hospital they took "X" rays of his foot and operated. He had a small hole "finger sized" in his heel and the skin was damaged on one side. He said the bone inside was smashed. His right lower arm was peppered with fragments (he showed the scars). They removed stones from his arm when they cleaned the wounds which healed very quickly. The foot was terribly painful. After they operated he woke up with a splint on his leg holding his foot at a right angle and leaving the wound open.

He needed a prosthetic shoe to walk but it was still painful and his "leg shakes inside". The demining company gave him his first shoe but even with it he could not carry anything when walking and could not walk very far. When interviewed, his original prosthetic shoe had worn out and no longer fitted the wound. He said that his injured leg was shorter [hard to measure with the heel absent] and that it swelled when he used it. He said that he wished they had cut off his foot and given him a lower leg prosthetic and compensation. Then he could have got on with his life.

The victim's foot was photographed during the interview.
