DDASaccident228

DDAS Accident Report

Report date: 18/05/2006	Accident number: 228
Accident time: not recorded	Accident Date: 19/07/1997
Where it occurred: Sevarlije, Doboј	Country: Bosnia Herzegovina
Primary cause: Management/control inadequacy (?)	Secondary cause: Field control inadequacy (?)
Class: Missed-mine accident	Date of main report: 23/07/1997
ID original source: WL/EB/VT	Name of source: BiH MAC
Organisation: Name removed	
Mine/device: PMA-3 AP blast	Ground condition: agricultural (abandoned) bushes/scrub grass/grazing area trees
Date record created: 17/02/2004	Date last modified: 17/02/2004
No of victims: 1	No of documents: 2

REPORT ON MINE ACCIDENT AT SEVARLIJE, NEAR DOBOJ

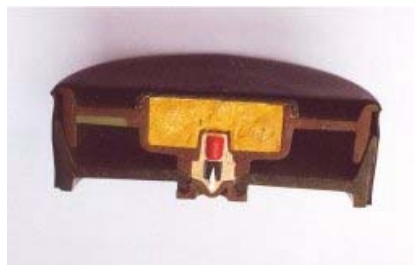
The injuries resulting from stepping on a PMA-3 vary from traumatic amputation to minor bruising. The picture below shows why this happens. It shows a cut-away section through a PMA-3. The 35g Tetryl is in the top and centre of the mine. The area of pressure-plate surrounding the HE is actually larger than the area of pressure-plate over it. If a victim is fortunate, they step on the pressure plate but the explosive charge is not beneath their foot.
