DDASaccident239

Humanitarian Demining Accident and Incident Database
AID

DDAS Accident Report

Report date: 18/05/2006	Accident number: 239
Accident time: 09:15	Accident Date: 27/07/1998
Where it occurred: Orya Khail village, Zurmat, Paktia Province	Country: Afghanistan
Primary cause: Field control inadequacy (?)	Secondary cause: Field control inadequacy (?)
Class: Excavation accident	Date of main report: [No date recorded]
ID original source: none	Name of source: MAPA/UNOCHA
Organisation: Name removed	
Mine/device: PMN AP blast	Ground condition: agricultural (abandoned) ditch/channel/trench soft
Date record created: 17/02/2004	Date last modified: 17/02/2004
No of victims: 1	No of documents: 1

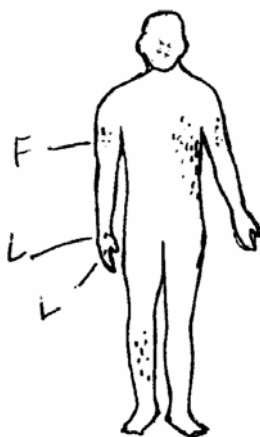
A medic's report included a sketch showing lacerations and fragments to the victim's upper right arm, left chest, upper left arm, face, right hand and lower right leg. The medic recorded that his pulse was 80/min, BP 120/80 and respiration 18/min.

His injuries were listed as: right hand fingers injured: right hand pollex amputated at third phalanx. Right arm injured and lacerated. Left arm injured. Left side chest haemorrhage. Nose and mouth also injured - incisors damaged but eyes normal.

The medic's sketch is reproduced here.
