DDASaccident240

Humanitarian Demining Accident and Incident Database
AID

DDAS Accident Report

Report date: 18/05/2006	Accident number: 240
Accident time: 08:40	Accident Date: 24/03/1998
Where it occurred: Chawni, Jali district, Paktia Province	Country: Afghanistan
Primary cause: Field control inadequacy (?)	Secondary cause: Inadequate equipment (?)
Class: Excavation accident	Date of main report: [No date recorded]
ID original source: none	Name of source: MAPA/UNOCHA
Organisation: Name removed	
Mine/device: PMN AP blast	Ground condition: hard metal scrap
Date record created: 17/02/2004	Date last modified: 17/02/2004
No of victims: 1	No of documents: 1

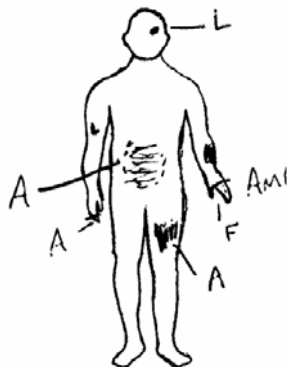
The field medical report stated that the victim had lost vision in his left eye, suffered traumatic amputation of his left thumb and index finger, fractured/dislocated his left wrist and elbow, suffered laceration and bruising to right hand and abdomen.

A medic's sketch is reproduced below.
