# DDASaccident255

# DDAS Accident Report

<b>Report date:</b> 15/03/2004	<b>Accident number:</b> 255
<b>Accident time:</b> 12:59	<b>Accident Date:</b> 21/09/1999
<b>Where it occurred:</b> Orcusa village, Dragas region, Rapce Onji, Nr Prizren	<b>Country:</b> Kosovo
<b>Primary cause:</b> Unavoidable (?)	<b>Secondary cause:</b> Inadequate equipment (?)
<b>Class:</b> Survey accident	<b>Date of main report:</b> 04/10/1999
<b>ID original source:</b> JR/MD/JF	<b>Name of source:</b> KMACC
<b>Organisation:</b> Name removed	
<b>Mine/device:</b> PMA-3 AP blast	<b>Ground condition:</b> bushes/scrub hard woodland
<b>Date record created:</b> 18/02/2004	<b>Date last modified:</b> 29/02/2004
<b>No of victims:</b> 1	<b>No of documents:</b> 3

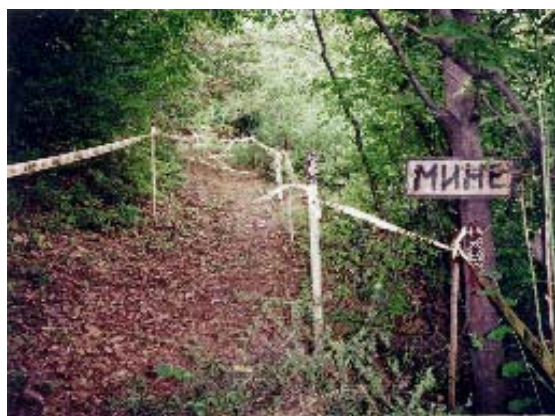
The clearance operation took place along a road/trail used by people from Albania who were stealing parts and items from the abandoned houses on the Kosovo side of the border. The area is a known mined area and is marked by the local population.

A locally made mine sign is shown in the picture of the site below.

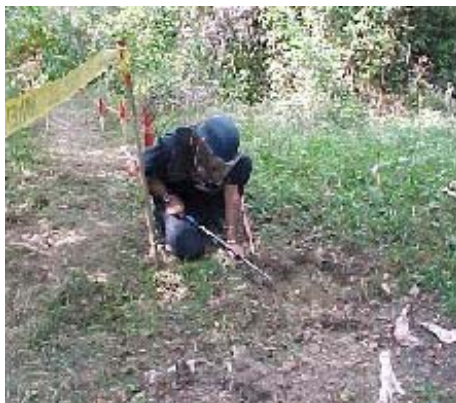
The victim, was clearing a lane past the remains of a dead cow and was already a metre past the cow when the accident occurred. While the victim was sweeping with the mine detector he received a signal on the right 10-cm overlap of the lane he was busy clearing. The ground at the accident site sloped slightly to the right of the lane. The victim started to prod in the area of the signal by using the prodder. When he was prodding on the right of his base stick, he activated an explosive device. This occurred at approximately 13:00.

The picture above shows a reconstruction of the victim's position at the time of the accident.

- The deminer is an experienced deminer.
- The deminer was wearing the proper safety equipment.
- The deminer was working in accordance with the SOP's.
- The CASEVAC procedure was followed and done in accordance with SOPs.
- The blast of the explosion deflected between the vest and the visor. The visor shattered.
- The right side of his body absorbed the biggest part of the blast.
- The deminer will keep his eye sight and suffer minor facial injuries.
- The only reliable means of communication on site was the SAT phone.
- The total time to evacuate the injury was 1 hour and 6 minutes.

- The demining group closed the site and conducted an investigation a few hours after the accident.
- The crater created by the blast is too big for a PMA 3 AP blast mine.
- The prodder used by the [sub-contracted demining group] is very heavy and the deminer loses some of the sensibility and need to use more pressure on it.
- The demining group reacted very well and handled the situation in a professional manner.
- This accident was non-preventable.

- The demining group will have to sweep the area to find or confirm the information on the type of mine.
- Refresher procedures on the prodding technique should be given to the de-miners of the group and excavation drills should be developed when the ground is not even.
- The long and heavy version of the prodder used by [the sub-contracted deminers] should be replaced.
- Communication system should be put in place as soon as possible.
- A statement from the injured deminer should be taken as soon as possible.
- Every organisation involved in mine/UXO clearance in Kosovo should be practicing their CASEVAC procedures and to take the constant increasing road traffic on the roads and towns in consideration.
- We are not sure what type of device the deminer initiated and the site therefore will have to be investigated.

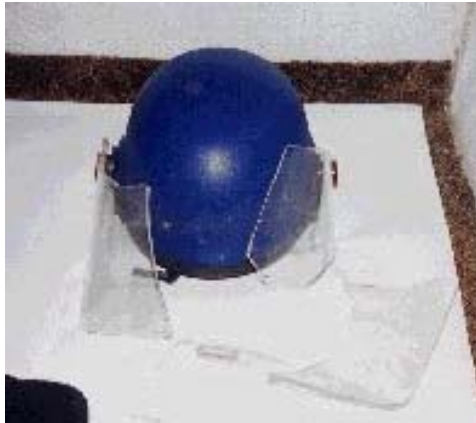
The secondary cause of the accident is listed as "*Inadequate equipment*" because, if the investigators were correct and the prodder does reduce tactile feedback, the prodder was inadequate. The visor and communications equipment at the site were also inadequate.

The visor was entirely unmarked by "soot" or earth in the blast, so it was not directly in the fragment cone associated with the blast, yet it shattered. This leads me to suspect that it was either made from perspex (much cheaper than polycarbonate) or was poorly manufactured so that stresses were locked into it. The clarity of the pieces shown makes the stress theory unlikely. The visor appears to be both thinner than the 5mm standard and very clean. It may have been cleaned before examination to remove marks on the inside (which might have provided evidence that it was raised). The damage to the visor implies that it was a) raised and b) that it may have been made of thin polycarbonate or cheap perspex – both of which fail to meet any approved standard for blast protection. If this was the case, the supply of this equipment would represent a serious management failing. But the cleanliness of the visor raises the possibility that it was not involved in the blast at all. It may have been deliberately broken after the blast to excuse the injuries to the victim's face and eyes.
