DDASaccident257

Humanitarian Demining Accident and Incident Database
AID

DDAS Accident Report

Report date: 18/05/2006	Accident number: 257
Accident time: 08:32	Accident Date: 24/05/1999
Where it occurred: Plowshare minefield, Cordon Sanitaire	Country: Zimbabwe
Primary cause: Unavoidable (?)	Secondary cause: Inadequate equipment (?)
Class: Excavation accident	Date of main report: [No date recorded]
ID original source: none	Name of source: KMS
Organisation: Name removed	
Mine/device: R2M2 AP blast	Ground condition: woodland (bush)
Date record created: 18/02/2004	Date last modified: 18/02/2004
No of victims: 1	No of documents: 2

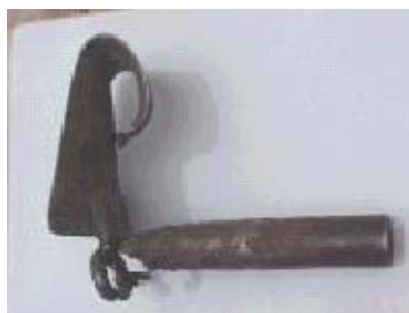
The primary cause of this accident is listed as "*Unavoidable*" because the victim appears to have been working properly in accordance with his SOPs when the accident occurred. The damage to his hand was almost certainly a consequence of using an inappropriate tool. The secondary cause is listed as "*Inadequate equipment*".

A picture of one of the group's excavation trowels after an accident is shown above. This example did not break entirely in two.

Although the use of tools like this (when straight) is easy – it is difficult to use them at the correct angle and the user's hand is unacceptably close to any detonation.

The investigators recommended that a period of re-training be started concentrating on "signal investigation" and "prodding/excavating drills". Deminers must be instructed not to continue uncovering any mine that appears to be damaged. The investigators also called for "more research and development of excavation tools".

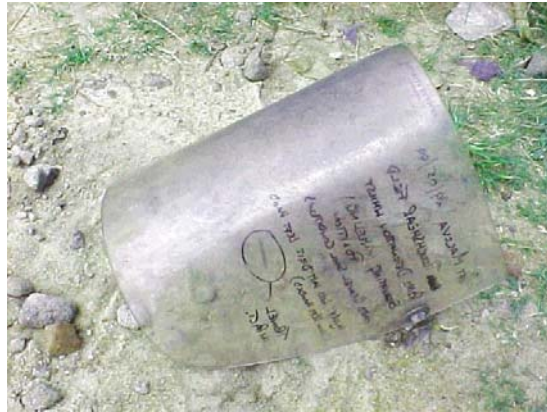
The visor was marked with a short cut (circled in the photograph) that penetrated the 5mm polycarbonate fully at its central point. The cut was made by the edge of the victim's trowel and the force required to cut the visor implies that the victim's face would have been severely injured if the visor had not been in place. (The visor had been written on and was used in training as a warning to deminers to keep the visor down.)
