DDASaccident262

DDAS Accident Report

Report date: 15/03/2004	Accident number: 262
Accident time: 13:25	Accident Date: 30/10/1999
Where it occurred: MNB South, Nr Ljubance	Country: Kosovo
Primary cause: Unavoidable (?)	Secondary cause: Victim inattention (?)
Class: Victim inattention	Date of main report: 11/12/1999
ID original source: KC/MD/JF	Name of source: KMACC
Organisation: Name removed	
Mine/device: PMA-2 AP blast	Ground condition: leaf litter route/path
Date record created: 18/02/2004	Date last modified: 03/03/2004
No of victims: 1	No of documents: 2

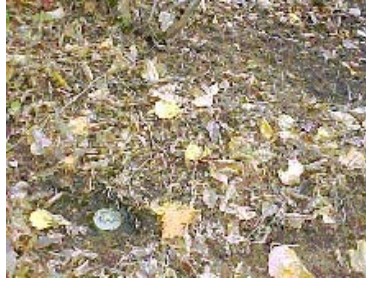
The Accident report included pictures of the accident site which showed the victim's boot and others showing the second PMA-2 less than a meter to the left of the small crater caused by the first mine. (The second mine was found using one of the detectors used at the site.)

The photograph below shows the second mine and the shallow "crater" (top right) of the first mine.
