DDASaccident263

DDAS Accident Report

Report date: 15/03/2004	Accident number: 263
Accident time: 10:00	Accident Date: 30/11/1999
Where it occurred: One km west of Ladrovac village, Suva Rica, MNB South	Country: Kosovo
Primary cause: Other (?)	Secondary cause: Other (?)
Class: Missed-mine accident (survey)	Date of main report: 02/12/1999
ID original source: KC/MD/JF	Name of source: KMACC
Organisation: Name removed	
Mine/device: PMA-2 AP blast	Ground condition: leaf litter route/path woodland
Date record created: 18/02/2004	Date last modified: 03/03/2004
No of victims: 1	No of documents: 3

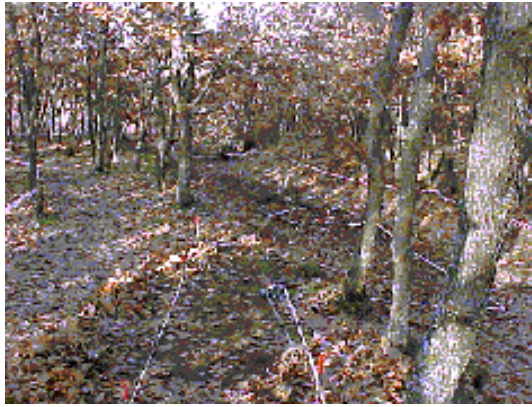
4. As the Team Leader was looking for any signs of the benchmark or any other marking from the site, he used a track well used by the locals. This track had hazard warning tape leading down (red and white chevron tape), either side of it forming a corridor. There were no mine signs or any other signs of restricting access and the track was marked in a way that it should be safe to use. The Victim was tasked to park 15 metres down the track and the Team Leader and the Victim alighted from the vehicle. The Team Leader proceeded down the track on foot with the Victim 10 metres behind. A detonation took place and the Victim set off a mine. The Team Leader took immediate action to remove the Victim from the dangerous area and initiated casevac procedures.

- The accident place was marked with red and white chevron plastic tape on both sides.
 - There were no mine signs visible at this time.
 - Local population frequently used the track.

[The picture below shows the accident site during the investigation when extra tapes were in place.]

8. The demining group's staff then erected mine signs at the entrance to the track. The entrance was also marked with mine tape. In the opinion of the Operations Manager, there was no requirement to forensically seal any mine/UXO clearance equipment as no mine/UXO clearance activity was being undertaken at the time of the accident.

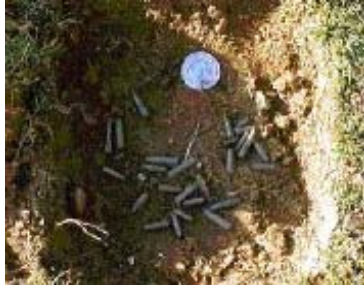
15. A substantial amount of metal was found in the area marked as safe. [One of the scrap-areas is shown in the picture above.]
16. On arrival to the MACC HQ, verification was done in the weekly report to identify which organisation had been working in that area. It was found that Group C had teams working exactly in this area during the week of 1- 6 November 1999.
17. On the morning of the 2 November the Programme Manager from Group C came to MACC HQ to clarify what had happened and to explain what his group intended to do with this dangerous area. In the afternoon, he came back with the expatriate in charge of the team that did the marking at the accident site and they gave a brief explanation of what had occurred three weeks before.
