DDASaccident266

DDAS Accident Report

Report date: 23/03/2004	Accident number: 266
Accident time: 17:05	Accident Date: 20/04/00
Where it occurred: Nr Kraljane, MNBW district, Gjavoka municipality	Country: Kosovo
Primary cause: Management/control inadequacy (?)	Secondary cause: Inadequate training (?)
Class: Detection accident	Date of main report: 03/05/2000
ID original source: MD/KC/JF	Name of source: KMACC
Organisation: Name removed	
Mine/device: PMA-3 AP blast	Ground condition: bushes/scrub woodland (light)
Date record created: 18/02/04	Date last modified: 23/03/04
No of victims: 1	No of documents: 3

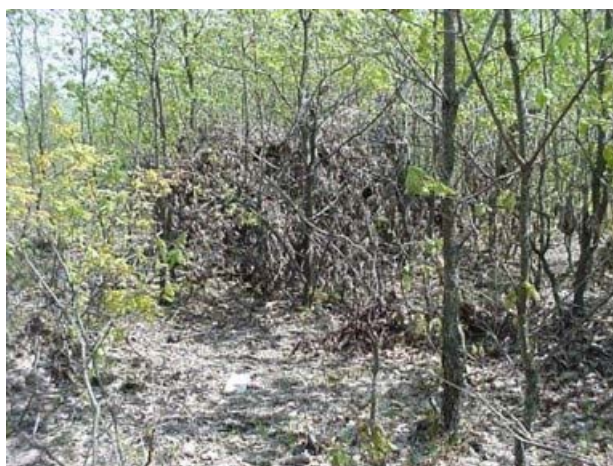
The picture above shows the mined area beyond the accident site.

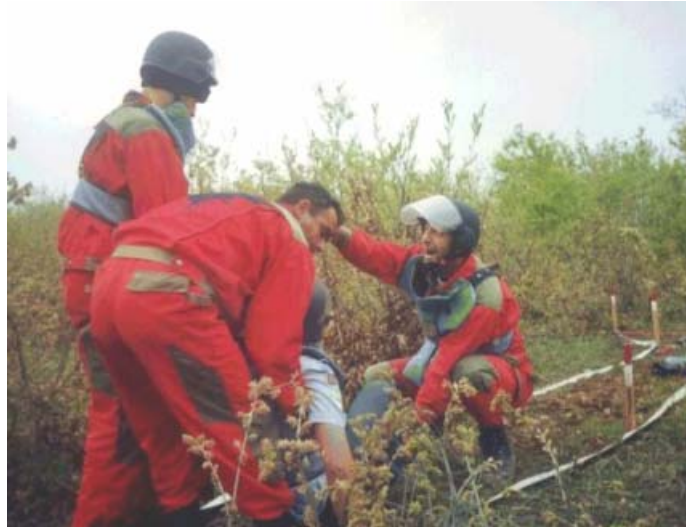
The victim stated that he had swept the area where the mine detonated and got no reading. It is not recorded how the victim reached the safe lane. Within seconds, two deminers and two supervisors were helping him in the one meter wide safe lane. The photograph below was taken as the victim was being evacuated. The investigators called it a "bad example of command and control" because the "one metre wide lane is overcrowded and offers potential for further injuries. Visors were also not worn and worn raised.

The investigators also found that the demining groups SOPs were not adhered to during the clearance, that the risks taken by the victim could have caused a fatality, that the victim was experienced with a senior position but wore his visor raised and did not test the detector properly before using it. They also found that the "extraction of [the victim] from the minefield was executed dangerously".

The photographs of the rescue team crowded in a narrow lane with visors raised was a further example of inadequate Field management.

The investigators recommended that the demining group's management take disciplinary action against the victim, carry out CASEVAC exercises for victim "extraction" as soon as possible and review their methods of testing the detector to include using a test-piece buried in soil.

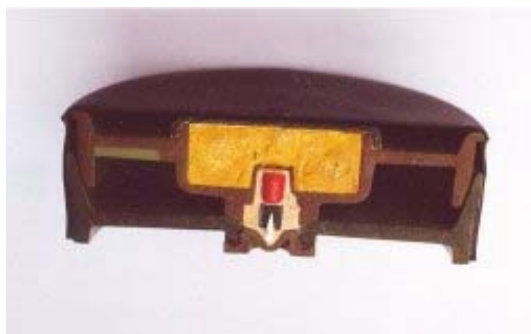
The PMA-3 blast mine contains a very small high explosive charge. This accident illustrates how the results of stepping on a PMA-3 can be a lottery. This may be because of the design of the mine or because its depth sometimes allows energy to dissipate prior to impact with the foot. Crater depth in this case may have provided a clue – especially because the crater resulting from the previous accident at the site had been photographed – so the failure to record the crater in this accident is regrettable.

The injuries resulting from stepping on a PMA-3 vary from bruising to traumatic amputations. The picture below shows why this happens. It shows a cut-away section through a PMA-3. The 35g Tetryl is in the top and centre of the mine. The area of pressure-plate surrounding the HE is actually larger than the area of pressure-plate over it. If a victim is fortunate, they step on the pressure plate but the explosive charge is not beneath their foot.
