DDASaccident266

Humanitarian Demining Accident and Incident Database
AID

DDAS Accident Report

Report date: 23/03/2004	Accident number: 266
Accident time: 17:05	Accident Date: 20/04/00
Where it occurred: Nr Kraljane, MNBW district, Gjavoka municipality	Country: Kosovo
Primary cause: Management/control inadequacy (?)	Secondary cause: Inadequate training (?)
Class: Detection accident	Date of main report: 03/05/2000
ID original source: MD/KC/JF	Name of source: KMACC
Organisation: Name removed	
Mine/device: PMA-3 AP blast	Ground condition: bushes/scrub woodland (light)
Date record created: 18/02/04	Date last modified: 23/03/04
No of victims: 1	No of documents: 3

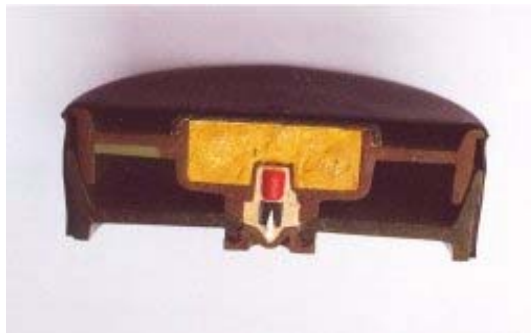
The PMA-3 blast mine contains a very small high explosive charge. This accident illustrates how the results of stepping on a PMA-3 can be a lottery. This may be because of the design of the mine or because its depth sometimes allows energy to dissipate prior to impact with the foot. Crater depth in this case may have provided a clue – especially because the crater resulting from the previous accident at the site had been photographed – so the failure to record the crater in this accident is regrettable.

The injuries resulting from stepping on a PMA-3 vary from bruising to traumatic amputations. The picture below shows why this happens. It shows a cut-away section through a PMA-3. The 35g Tetryl is in the top and centre of the mine. The area of pressure-plate surrounding the HE is actually larger than the area of pressure-plate over it. If a victim is fortunate, they step on the pressure plate but the explosive charge is not beneath their foot.
