### DDASaccident267

*Humanitarian Demining Accident and Incident Database*

# DDAS Accident Report

<b>Report date:</b> 18/05/2006	<b>Accident number:</b> 267
<b>Accident time:</b> 11:08	<b>Accident Date:</b> 22/05/2000
<b>Where it occurred:</b> Nr Kodralija, Peje District, Decani Province	<b>Country:</b> Kosovo
<b>Primary cause:</b> Unavoidable (?)	<b>Secondary cause:</b> Field control inadequacy (?)
<b>Class:</b> Vegetation removal accident	<b>Date of main report:</b> 01/06/2000
<b>ID original source:</b> KC/MD/JF	<b>Name of source:</b> KMACC
<b>Organisation:</b> Name removed	
<b>Mine/device:</b> PMA-3 AP blast	<b>Ground condition:</b> ditch/channel/trench metal scrap route (verge) trees
<b>Date record created:</b> 18/02/2004	<b>Date last modified:</b> 17/03/2004
<b>No of victims:</b> 1	<b>No of documents:</b> 2

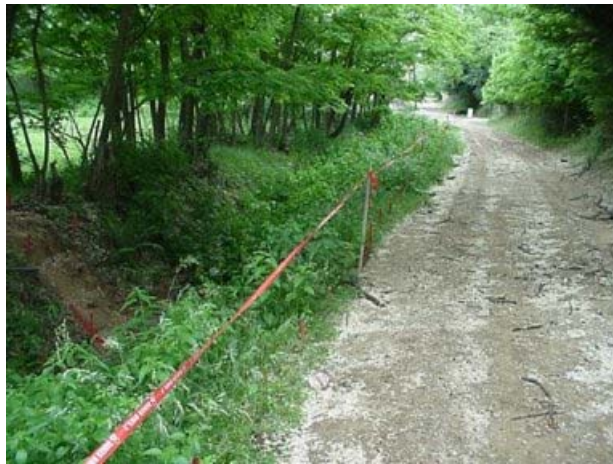
The victim was working in a shady ditch where visibility was poor.

The photograph above shows a dirt road with a line of low trees and a ditch alongside.

The ditch was in deep shadow. The ditch was heavily contaminated with rubbish so a detector was not used.

The investigators recommended that the demining group "must" provide better supervision of their least experienced deminers "especially in complicated clearance tasks. It was further recommended that "alternative ways of clearance" be considered (mechanical bush cutter), that the group conduct a CASEVAC exercise, and that "where obstacles like ditches, rocks, high contamination, etc occur, a separate plan to approach and clear these obstacles" should be made prior to clearance.

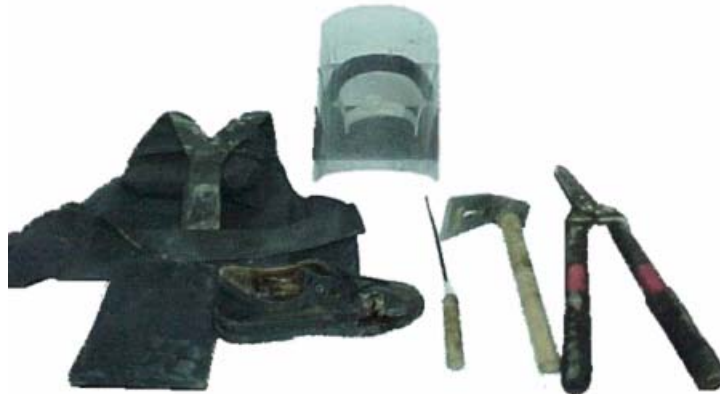
The picture above shows the victim's tools, PPE and the light "trainer" footwear he was wearing. The "trainer" is torn beside the toes but shows very little damage.

There is dust/debris blown into the underside of the shears and bottom edge of the visor which probably indicates the deminer was almost over the top of the blast. The body armour prevented any penetration of fragments to the torso.
