# DDASaccident267

# DDAS Accident Report

<b>Report date:</b> 18/05/2006	<b>Accident number:</b> 267
<b>Accident time:</b> 11:08	<b>Accident Date:</b> 22/05/2000
<b>Where it occurred:</b> Nr Kodralija, Peje District, Decani Province	<b>Country:</b> Kosovo
<b>Primary cause:</b> Unavoidable (?)	<b>Secondary cause:</b> Field control inadequacy (?)
<b>Class:</b> Vegetation removal accident	<b>Date of main report:</b> 01/06/2000
<b>ID original source:</b> KC/MD/JF	<b>Name of source:</b> KMACC
<b>Organisation:</b> Name removed	
<b>Mine/device:</b> PMA-3 AP blast	<b>Ground condition:</b> ditch/channel/trench metal scrap route (verge) trees
<b>Date record created:</b> 18/02/2004	<b>Date last modified:</b> 17/03/2004
<b>No of victims:</b> 1	<b>No of documents:</b> 2

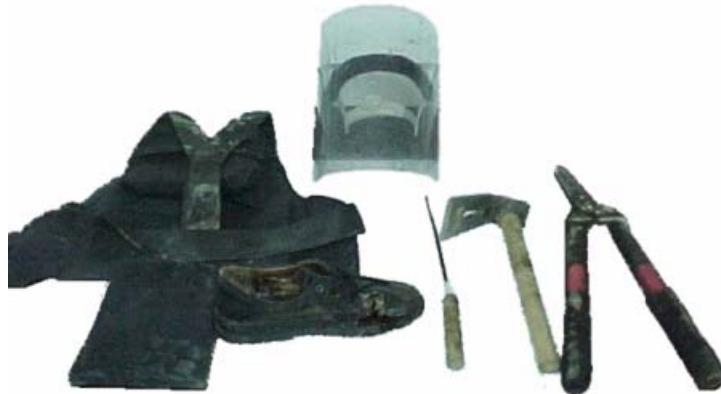
The picture above shows the victim's tools, PPE and the light "trainer" footwear he was wearing. The "trainer" is torn beside the toes but shows very little damage.

There is dust/debris blown into the underside of the shears and bottom edge of the visor which probably indicates the deminer was almost over the top of the blast. The body armour prevented any penetration of fragments to the torso.
