DDASaccident271

DDAS Accident Report

Report date: 18/05/2006	Accident number: 271
Accident time: 11:35	Accident Date: 28/07/2000
Where it occurred: Nr Kralijane, SE of Peje	Country: Kosovo
Primary cause: Management/control inadequacy (?)	Secondary cause: Inadequate training (?)
Class: Missed-mine accident	Date of main report: 08/08/2000
ID original source: KC/PS/JF	Name of source: KMACC
Organisation: Name removed	
Mine/device: PMA-3 AP blast	Ground condition: bushes/scrub woodland (light)
Date record created: 18/02/2004	Date last modified: 17/03/2004
No of victims: 2	No of documents: 2

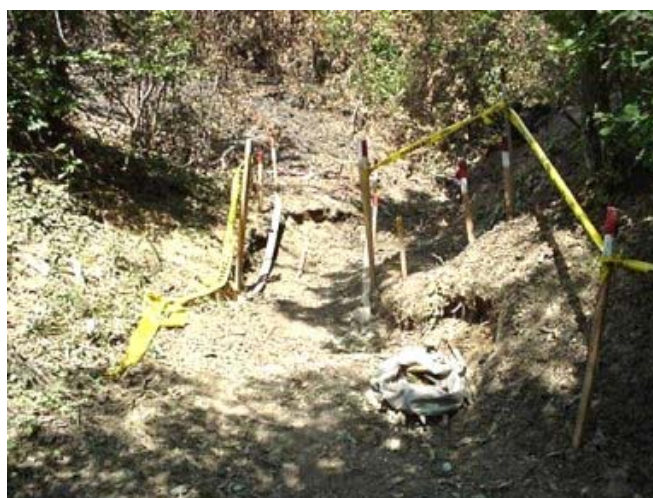
At 11:35 Victim No.1 moved to edge of the cleared area to look at the mine he had seen and trod on a PMA-3 inside the area marked as cleared. "The victim walked/ran by himself to a safe area" where other deminers made him lie down and calmed him. The medics arrived and Victim No.1 was carried to the ambulance. He left for the Argentine KFOR hospital at 11:45 and arrived as 12:10. He was conscious at all times. The hospital released him "Later in the afternoon".

The photograph below shows the accident site.

The investigators found that the site was not laid out in accordance with the group's SOPs and the access lane was only one meter wide instead of two. The demining group's SOPs were also not followed over "the use of the base stick" and this caused the mine to be missed.

The investigators recommended that the demining group "review their training programme for deminers and supervisors" as a result of this and previous accidents. Refresher courses for deminers and supervisors must be given, and should cover the behaviour of a casualty in the event of an accident. The demining group was recommended to take "appropriate disciplinary action" against personnel in breach of SOPs.

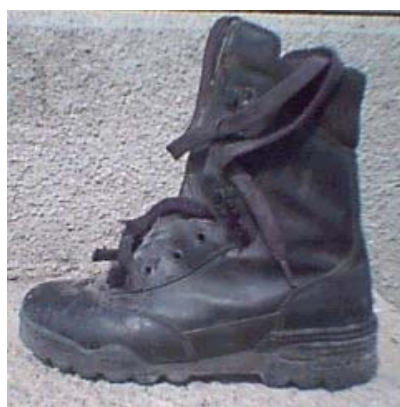
Photographs of Victim No.1's PPE and boot showed that the visor was dusty and the boot apparently undamaged apart from broken laces (which may have been cut to remove it).

The photograph alongside shows the victim's boot after the accident. It is not clear whether the laces were cut by the medics or broke in the explosion.
