## DDASaccident272

# DDAS Accident Report

<b>Report date:</b> 15/03/2004	<b>Accident number:</b> 272
<b>Accident time:</b> 08:20	<b>Accident Date:</b> 10/08/2000
<b>Where it occurred:</b> Nr Stajk and Miljaj, Gorazup region	<b>Country:</b> Kosovo
<b>Primary cause:</b> Inadequate equipment (?)	<b>Secondary cause:</b> Management/control inadequacy (?)
<b>Class:</b> Missed-mine accident	<b>Date of main report:</b> 21/08/2000
<b>ID original source:</b> KC/MD/JF	<b>Name of source:</b> KMACC
<b>Organisation:</b> Name removed	
<b>Mine/device:</b> PMA-3 AP blast	<b>Ground condition:</b> bushes/scrub electromagnetic hard rocks/stones sparse trees
<b>Date record created:</b> 18/02/2004	<b>Date last modified:</b> 18/02/2004
<b>No of victims:</b> 1	<b>No of documents:</b> 3

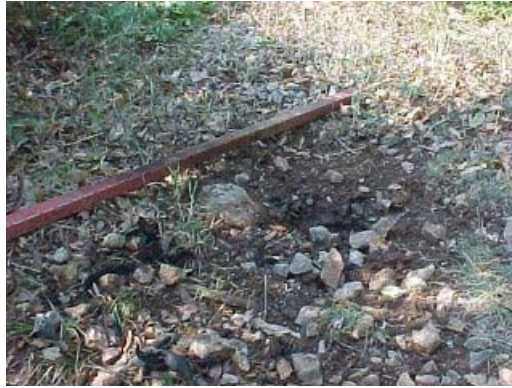
The picture above shows a clearance lane at the site and shows the typical vegetation. The vegetation at the clearance site, coupled with "the curvature of the clearance lane" meant that there were no witnesses to the accident.
