DDASaccident273

Humanitarian Demining Accident and Incident Database
AID

DDAS Accident Report

Report date: 15/03/2004	Accident number: 273
Accident time: 10:05	Accident Date: 25/08/2000
Where it occurred: Near Restelicia, Gora, MNB South	Country: Kosovo
Primary cause: Management/control inadequacy (?)	Secondary cause: Inadequate training (?)
Class: Handling accident	Date of main report: 17/09/2000
ID original source: KC/MD/JF	Name of source: KMACC
Organisation: Name removed	
Mine/device: Fuze	Ground condition: bushes/scrub grass/grazing area hard
Date record created: 18/02/2004	Date last modified: 18/02/2004
No of victims: 1	No of documents: 1

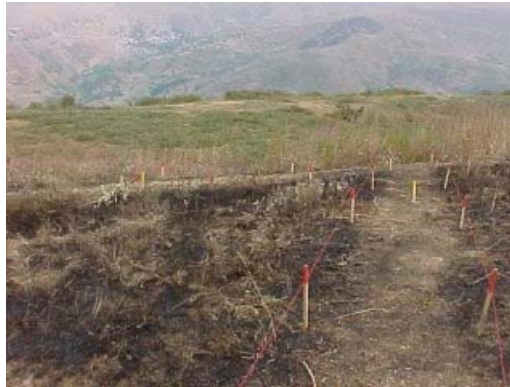
The accident occurred at a site with "several dangerous areas" recorded. The mines found were mainly PMA-3 and PMR-2A. TMA-5 AT mines had been present but "people from Albania" had removed most of them. Clearance work was progressing well "due to open ground and sparse vegetation" although some of the PMA-3 mines had been "affected" by

local people having burnt off the vegetation about three weeks previously. The ground was described as "semi-hard" and compacted with "small bush". A photograph showed very little ground cover and large areas of burnt ground. The weather was described as sunny with a temperature of 25C and a light breeze.

The photograph above shows the area being worked on.
