DDASaccident274

Humanitarian Demining Accident and Incident Database
AID

DDAS Accident Report

Report date: 18/05/2006	Accident number: 274
Accident time: 08:12	Accident Date: 23/05/2000
Where it occurred: Nhacondo-Inharrime, Inhambane Province	Country: Mozambique
Primary cause: Field control inadequacy (?)	Secondary cause: Unavoidable (?)
Class: Excavation accident	Date of main report: 26/05/2000
ID original source: none	Name of source: IND/HI
Organisation: Name removed	
Mine/device: GYATA-64 AP blast	Ground condition: grass/grazing area residential/urban sandy trees
Date record created: 18/02/2004	Date last modified: 18/02/2004
No of victims: 1	No of documents: 3

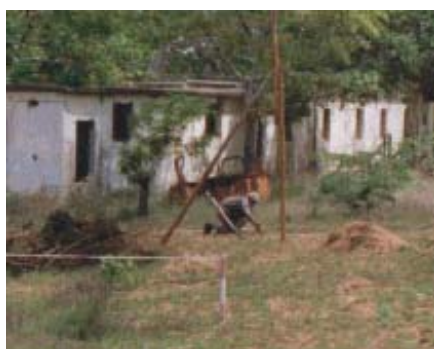
[The picture above shows a deminer excavating a detector reading. This is a "still" from a video made at the site during research in 1999.]

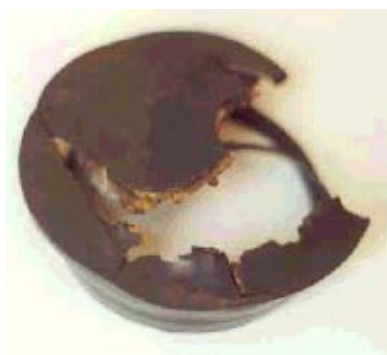
The crater opened by the explosion was about 17cm wide (across) and about 14cm deep.

[The picture above shows the rubber top of the Gyata-64 mine after the accident – clearly illustrating that the mine did not detonate as designed (photographed by the researcher later).]

During the excavation, the victim did not verify the depth of the mine. In trying to correct this, and due to the mine being at an angle of about 20 degrees, he struck the upper part of the mine and detonated it. Therefore the accident was caused by a bad digging technique and the angled position of the mine.

The demining group's own site investigation and an examination "of the fragments" indicated that the HE in the mine "was possibly in a degraded state". The facts that the trowel "remained intact" and there was no fragment damage to the deminer's "body armour" and visor were taken as evidence supporting the idea that the explosive in the mine had "degraded".

A demonstration on proper digging methods should be made and all Team Commanders told to use these methods.
