DDASaccident304

Humanitarian Demining Accident and Incident Database

-DDAS Accident Report

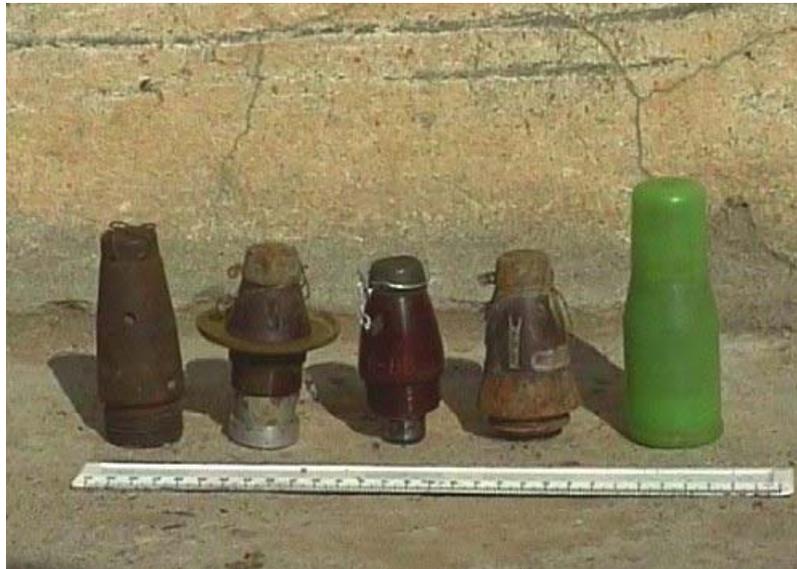
A battle Area Clearance (BAC) team was working in an area where the task comprised approximately 500 mortar bombs and shells. Most of the items were visible on the surface. People nearby had been interfering with the items trying to take them apart. The accident occurred when an EOD worker was making a final check over the cleared area. He then discovered a partly buried mortar (PD M-6) fuze. The fuze was already taken apart. The booster was removed and no safety pins (two) were in place. When the EOD worker handled the fuze the striker “sledged and initiated the detonator”.

The picture above was provided by the demining group and shows some of the fuzes they had encountered at the site.
